## Pacific View Condos – Gearhart, Oregon

### Electrical System - Building Assessment Report

December 2, 2022

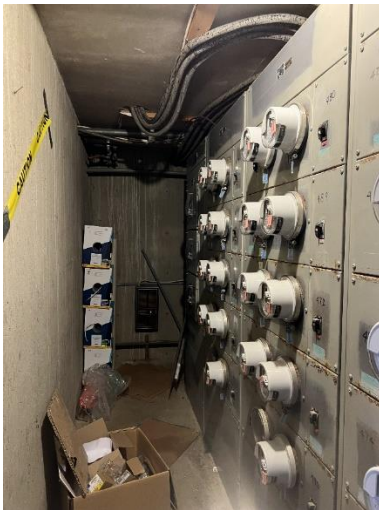
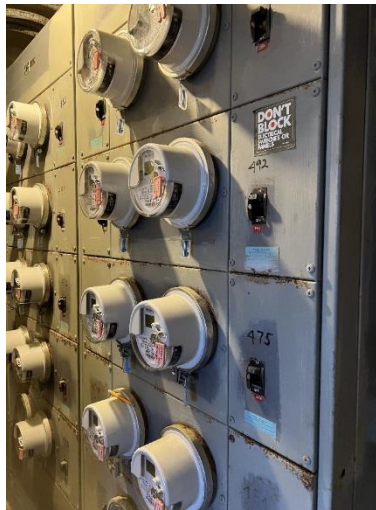
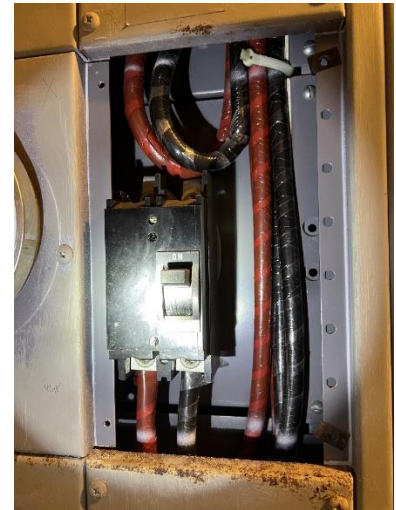
A 1600amp, 120/208vac, 3 phase, 4 wire commercial meter center is located at the sub-level main electrical room. The meter center consists of four sections, the incoming service section, and three-meter sections. The incoming service section consists of three 600amp sub-feed breakers to sub-feed the 3 meter sections. The 3 meter sections consists of 10 meter sockets each, each meter has a output breaker to feed an individual condo unit panel.

The meter center is original to the building (1960s), the Utility has replaced the meters with new electronic units. Some surface rust is present on the exterior of the equipment, the interior appears to be rust free, and only one breaker compartment was viewed. The unit is a Square-D brand, Power-Style Switchboard.

Per Square-D the unit is vintage equipment, and no longer supported by Square-D. Parts and circuit breakers are no longer available. The equipment and individual breakers are past the 30 years service life for electrical equipment.

The individual circuit breakers may or may not have been cycled and internal breaker components may be fused together and prevent the circuit breaker from tripping during an over current event. This condition could be a potential fire hazard.

- Complete replacement of the equipment.
- Or options for the existing equipment:
  - Infrared testing of the wiring connections could identify some faulty wiring connection problems.
  - Provide visual inspection of the internal bussing for signs of corrosion, dust, dirt.
  - Manually exercising the breakers to check for proper operation.
  - Have an electrical contractor check if rebuilt replacement breakers are an option.
  - Remove breakers and bench test by a third-party testing agency for functionality, failing breakers would need to be replaced with rebuilt units.

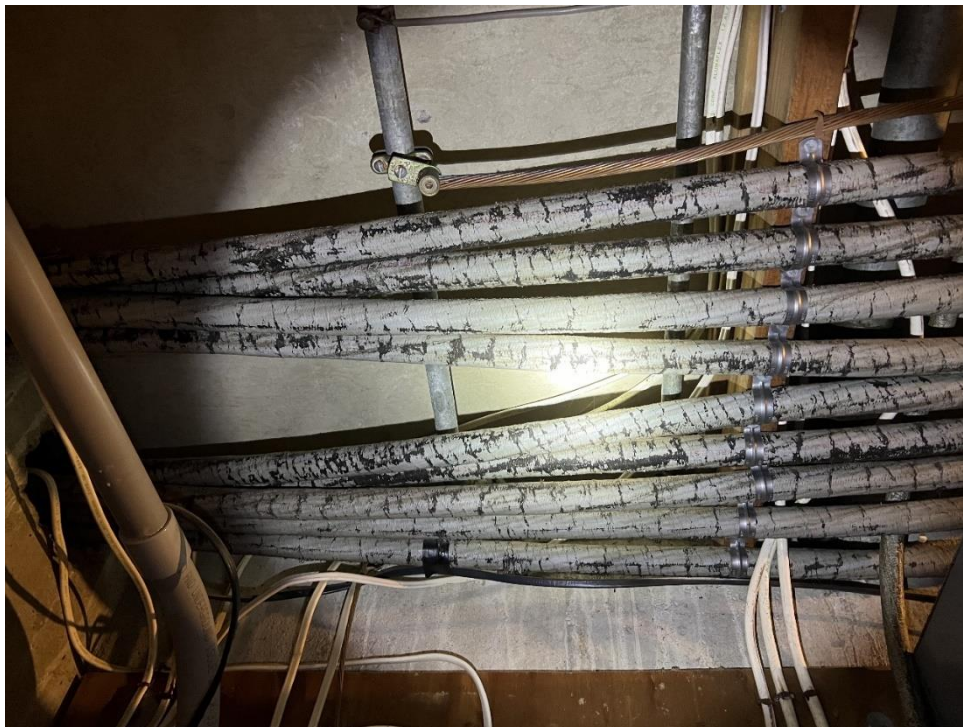
The main conductors from the meter center to the condo unit load center panels are insulated aluminum conductors inside a cloth type overall wrap. These are original to the building. Routing is open air and partially inside raceway. Open routing areas are fastened to the building framing with two hole straps.

- Check torque setting on the mechanical conductor terminations.
- Provide infrared testing to check for loose connections or potential connection issues.

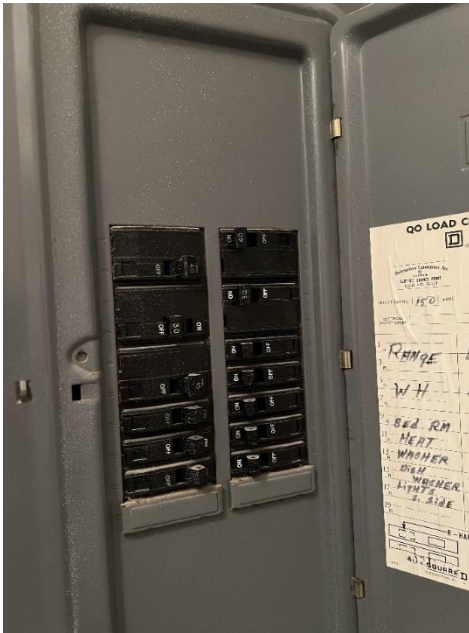
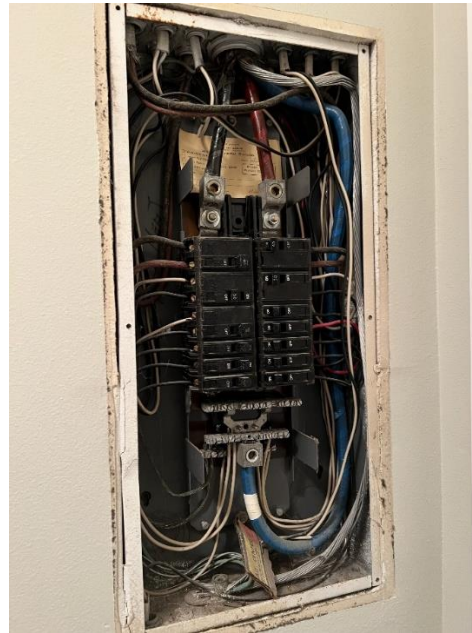
Condo Unit load centers are 208vac, 1 phase, 150amp. The typical unit viewed was a Square-D QO load center.

- Feeder Conductors:
  - No issues were noted for the aluminum conductors, and no corrosion was noted at the terminations viewed. Conductor terminals are mechanical set screw type.
- Condo Unit Load Centers:
  - The load center was in good condition, the QO panels are still serviceable, and new breakers are readily available for this panel type. Some corrosion was noted on a couple of the copper wires at the connection point to the breakers. Wires were a mix of copper and aluminum type conductors.

- Check wiring connections.
- Check for corrosion issues.
