# PACIFIC VIEW CONDOMINIUMS

## Preliminary Building Envelope and Limited Structural Observations

**Address:** 128 N Marion Ave, Gearhart, OR 97138

**Date:** November 22, 2022

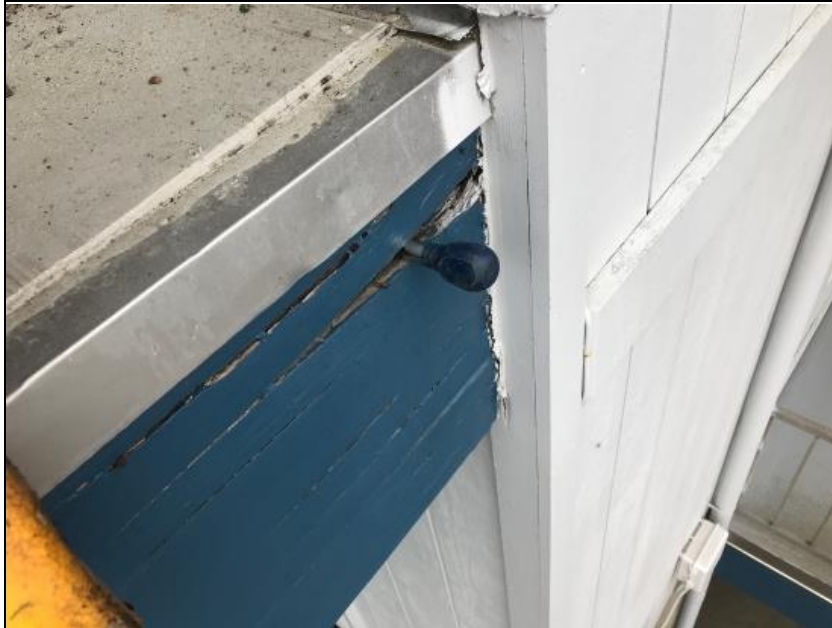
**Building #1238, Unit #479**

**Description:** Structural deck beams are severely water damaged and are unsafe to support code required loads.

**Photo Notes:** Water damaged deck support beam.

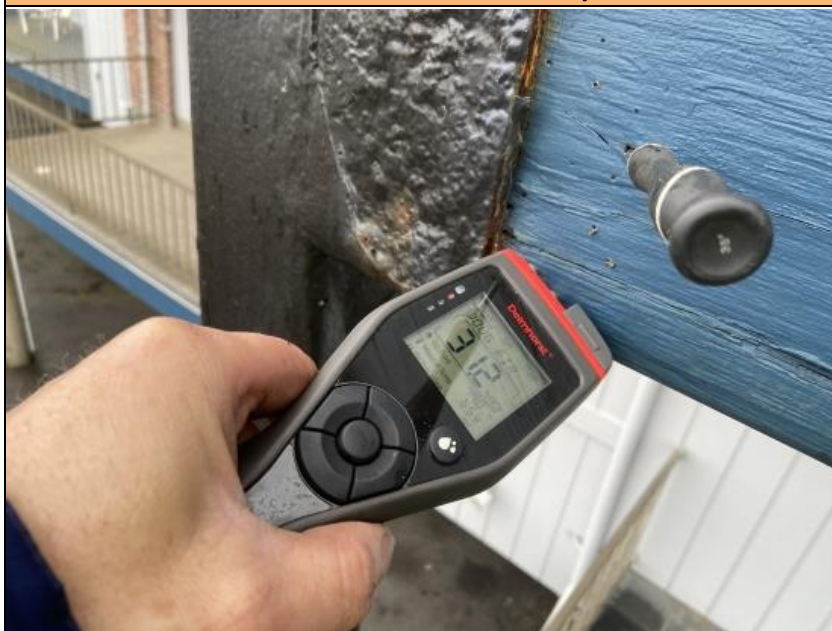
**Building #1238, Unit #484**

**Photo Notes:** Water damaged deck support beam

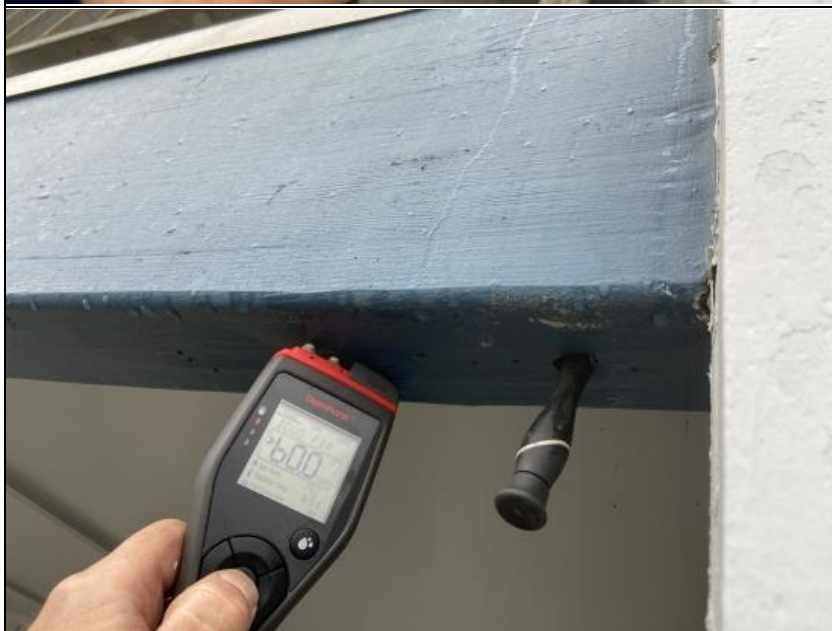
**Building #1238, Unit #493**

**Photo Notes:** Water damaged deck support beam

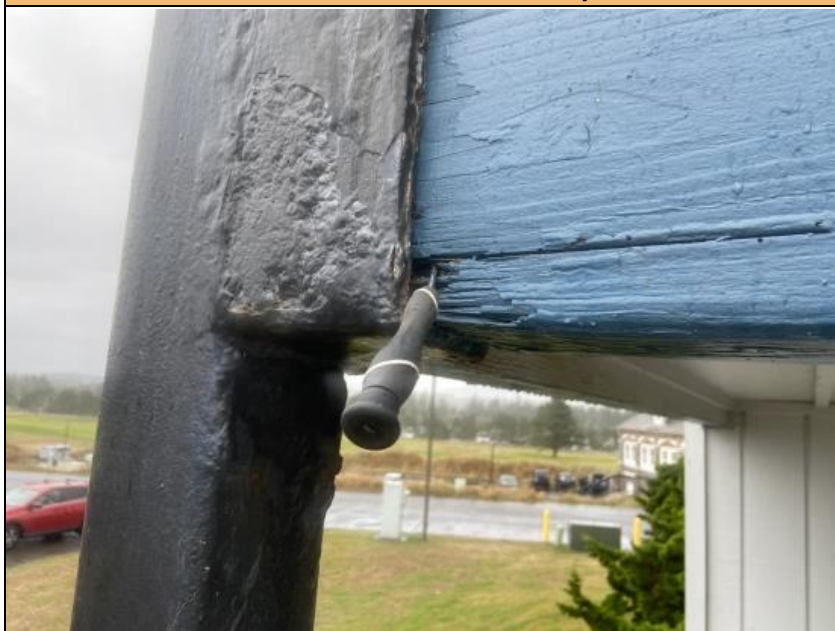
**Building #1238, Unit #476**

**Photo Notes:** Water damaged deck support beam

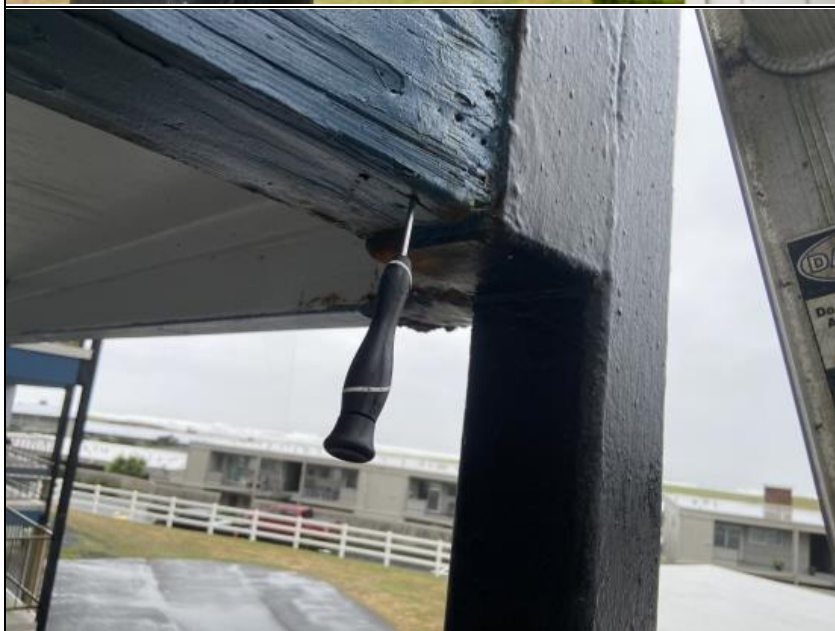
**Building #1238, Unit #481**

**Photo Notes:** Water damaged deck support beam

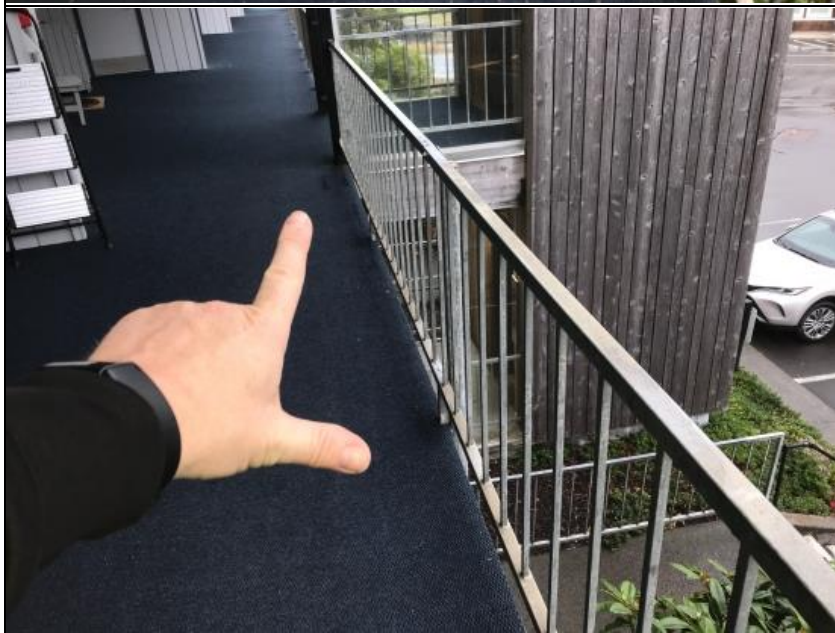
**Building #1238, Unit #480**

**Description:** Guardrails are loosely attached to the building and may not support code required loading.

**Photo Notes:** Loose guardrail connection

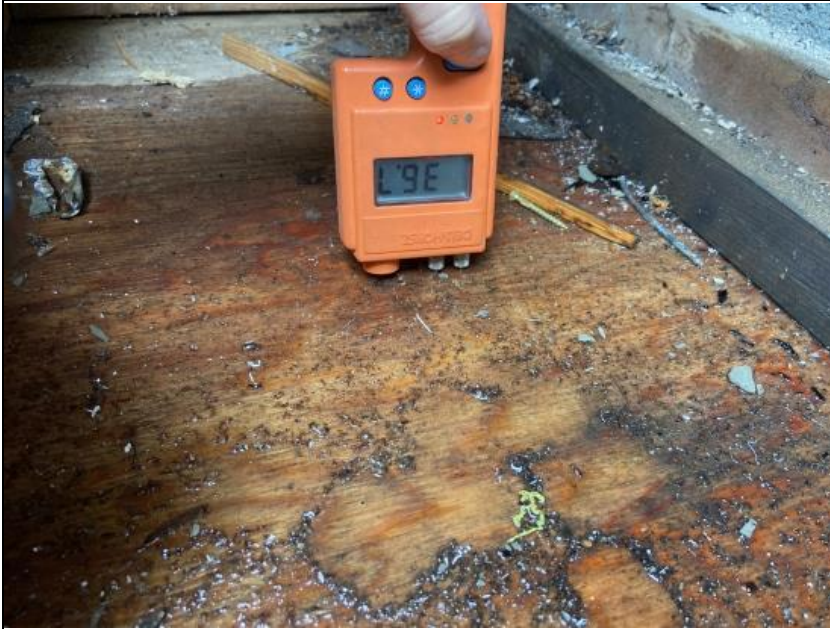
**Description:** J2 observed water damaged building components and improper installation methods at critical integration areas with the membrane.

**Photo Notes:** Water damage at roof access hatch.

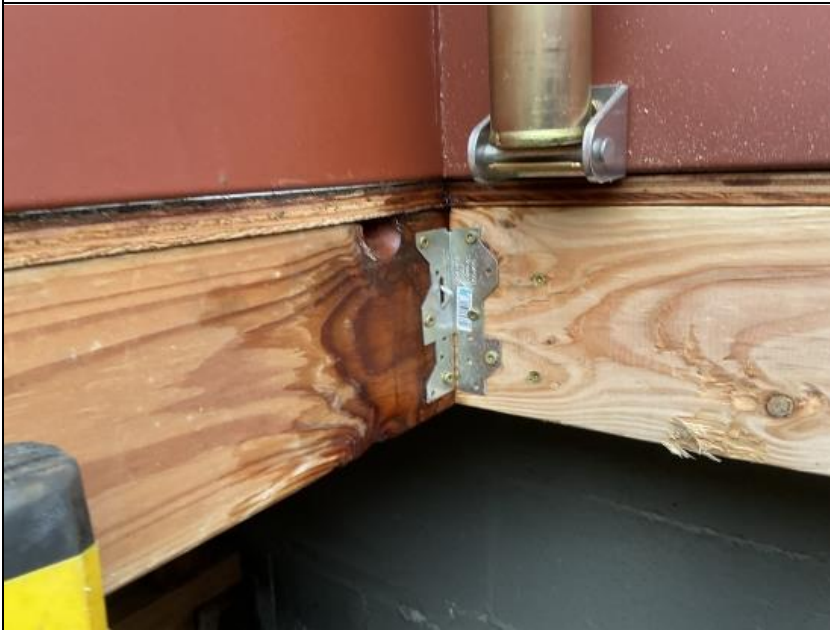
**Photo Notes:** Water damage at roof access hatch.

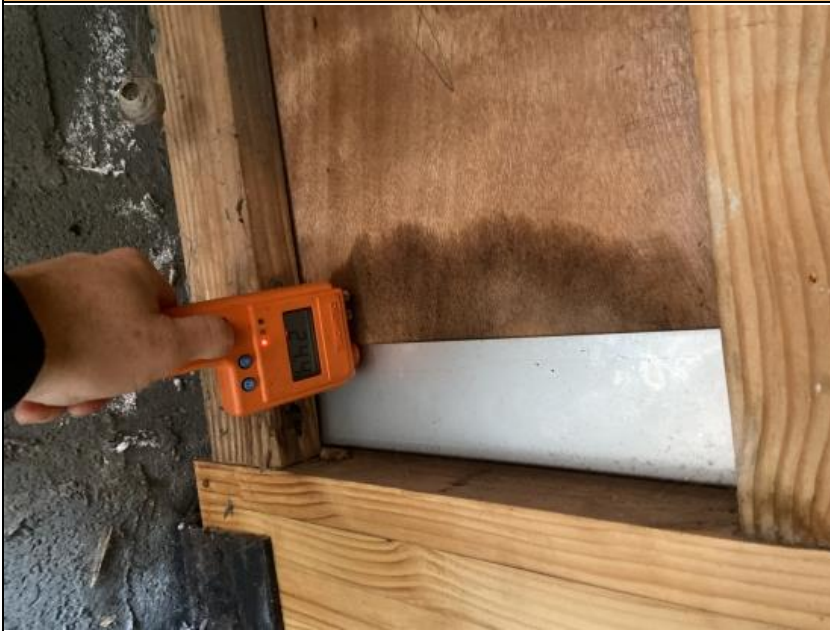
**Photo Notes:** Water damage on back side of sheathing below hatch.

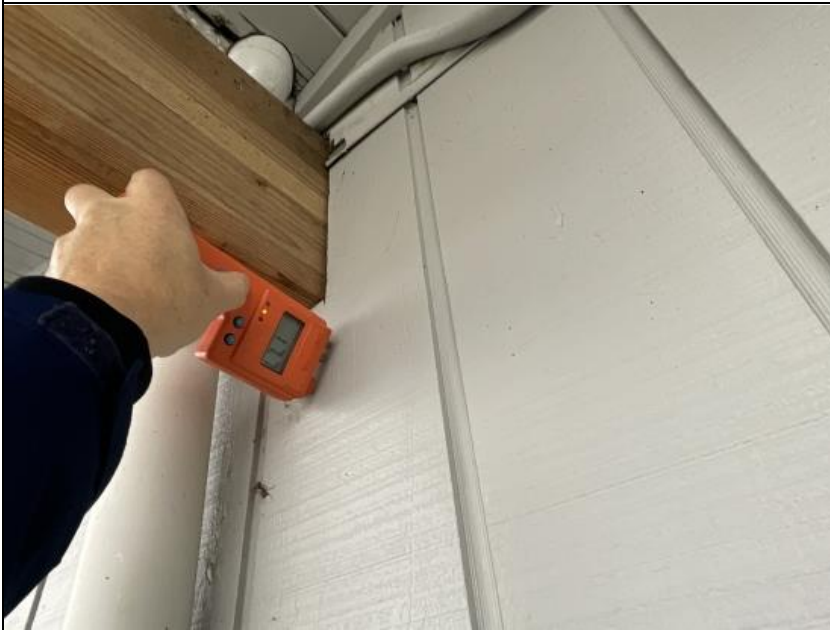
**Building #**N/A, **Unit #**N/A

**Photo Notes:** Elevated moisture levels in wall sheathing below roof penetration.

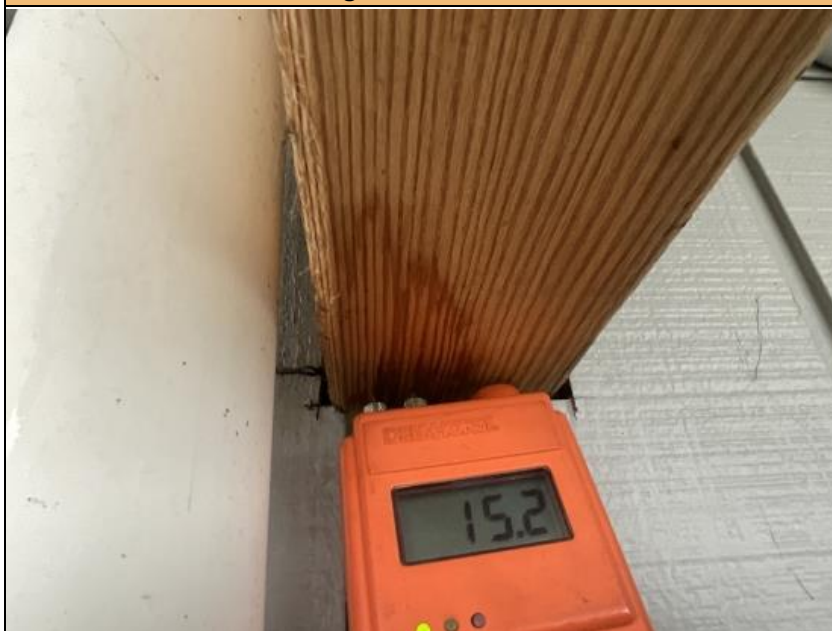
**Building #**N/A, **Unit #**N/A

**Photo Notes:** Elevated moisture levels and staining at beam to wall interface directly below roof penetration.

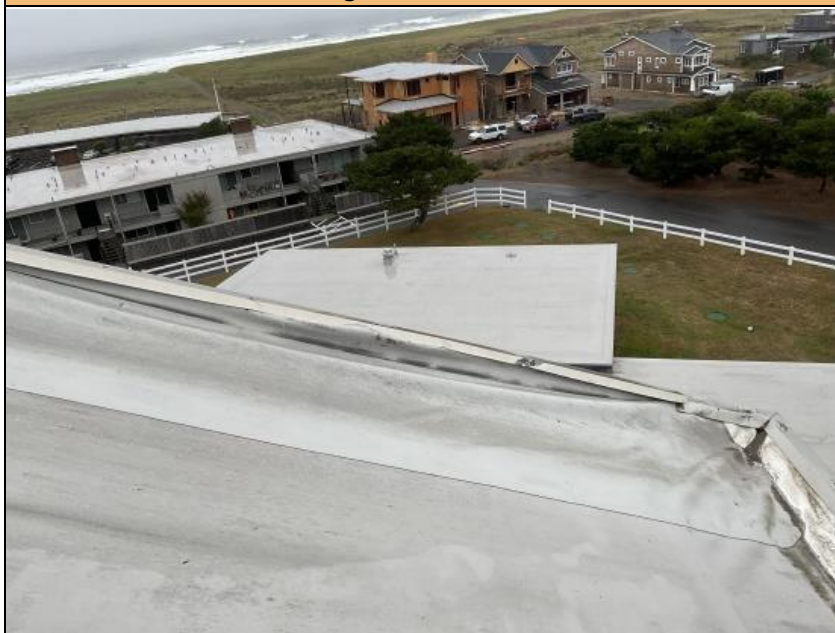
**Building #1238, Unit #N/A**

**Photo Notes:** Damaged drip edge flashing allows water underneath the roof membrane.

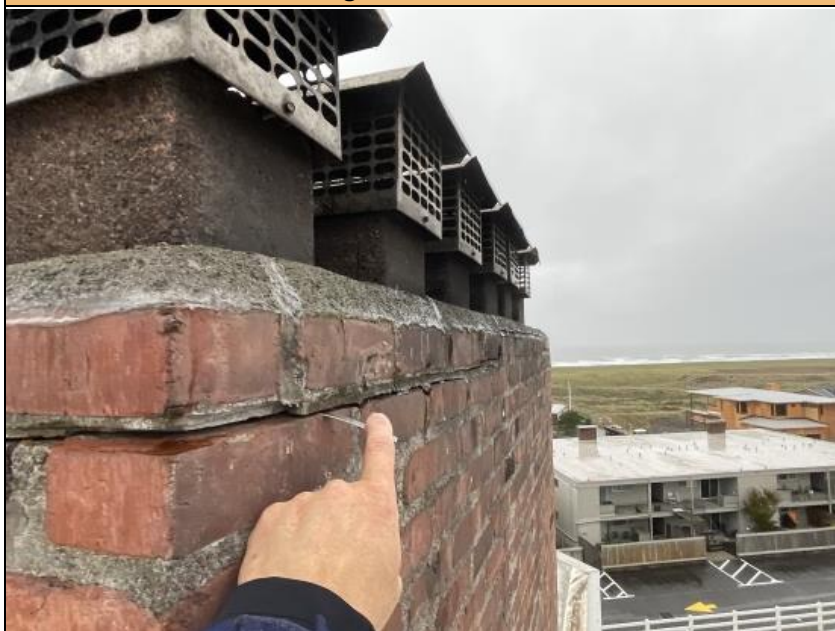
**Building #N/A, Unit #N/A**

**Photo Notes:** Mortar joints failing at brick chimneys

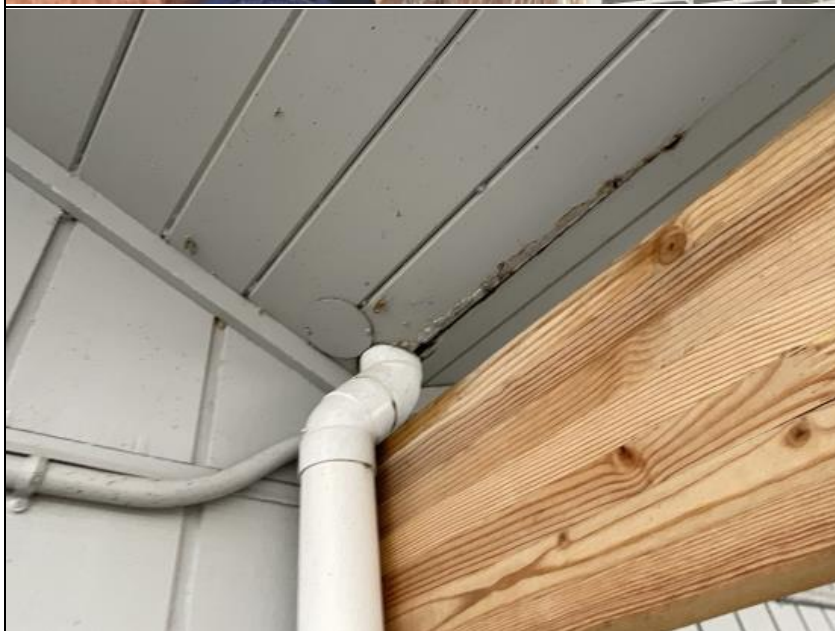
**Building #N/A, Unit #N/A**

**Photo Notes:** water damaged roof deck at penetration.

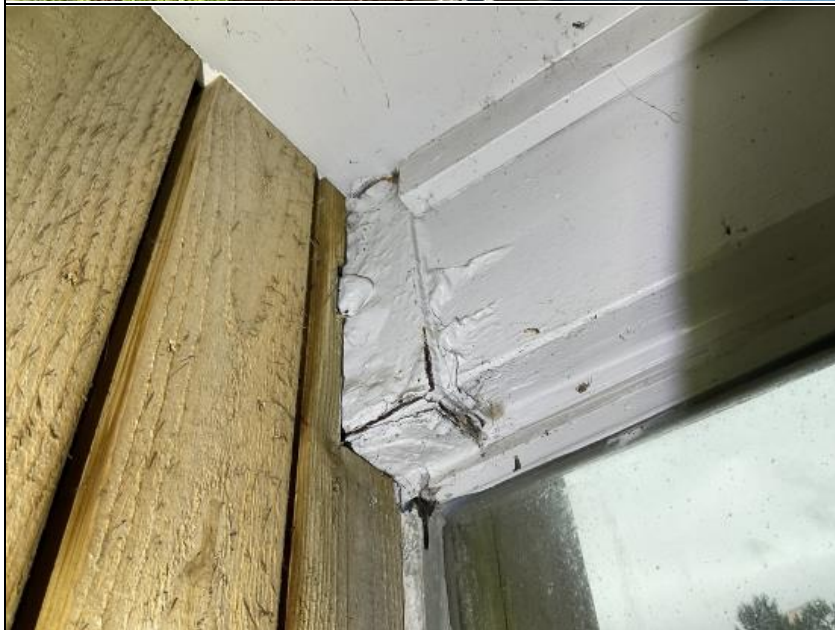
**Building #**N/A, **Unit #**N/A

**Description:** Mis-lapped and missing drip edge flashing at roof perimeter contributing to water damaged barge rafter and beams.

**Photo Notes:** Water damaged roof beam

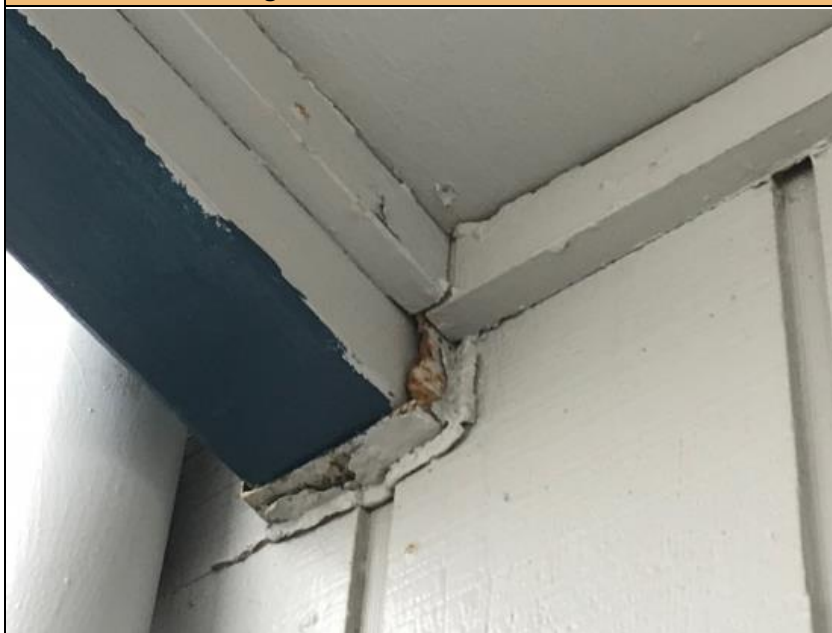
**Building #1238, Unit #482**

**Photo Notes:** Water damaged roof beam and hardware

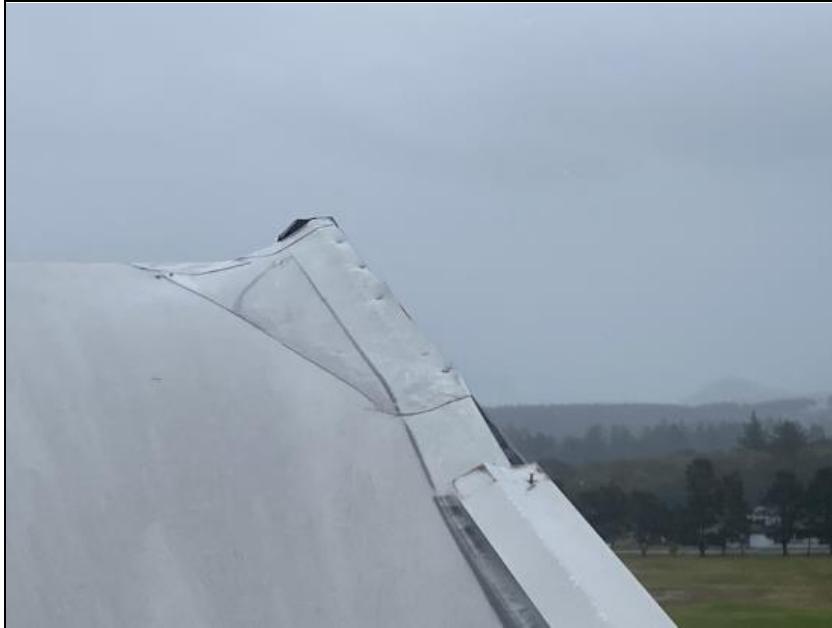
**Description:** J2 observed select areas where metal flashing were damaged, missing, and/or installed improperly.

**Severity Rating:** 3

**Photo Notes:** Missing flashing appears to have blown off.

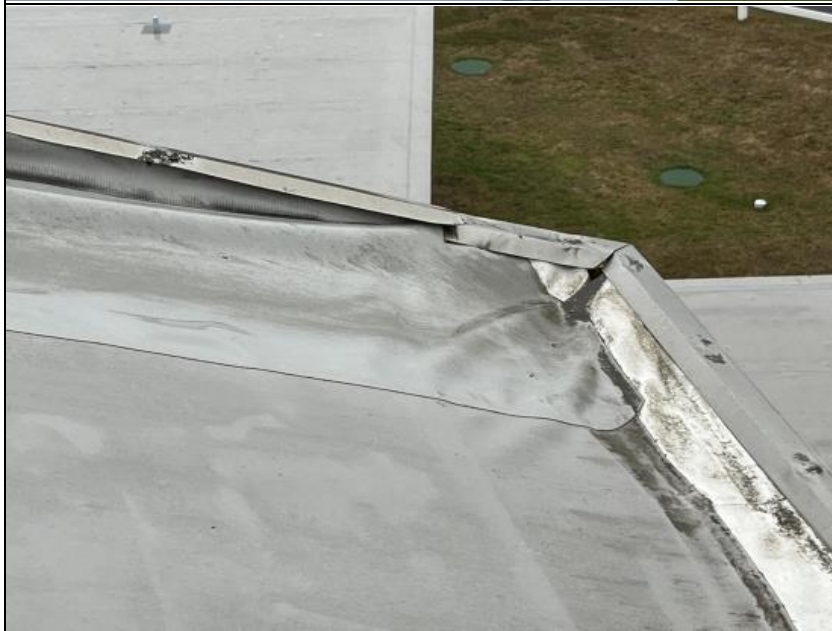
**Photo Notes:** Flashing improperly lapped, separating and not properly sealed.

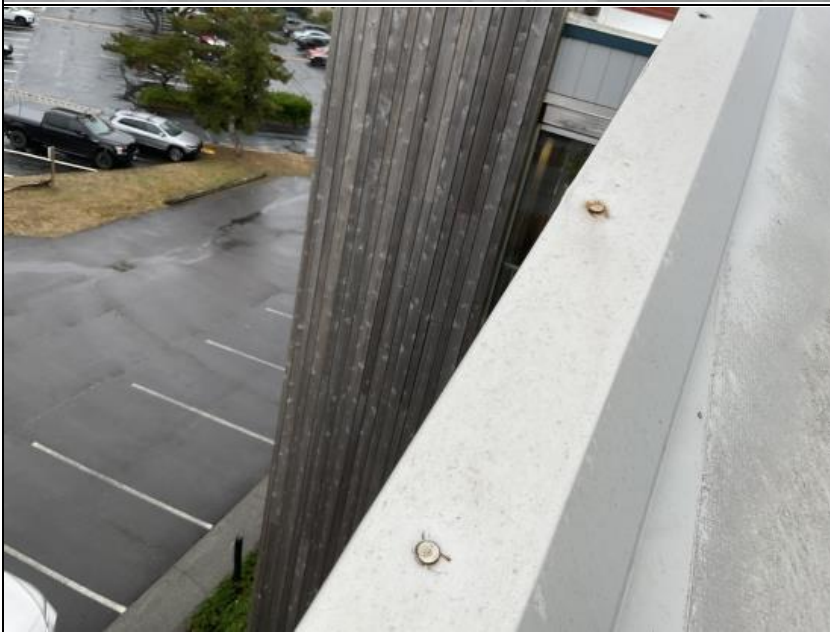
**Elevation:** East

**Photo Notes:** Flashings surface mounted with no sealant. Nails are loose and starting to back out.

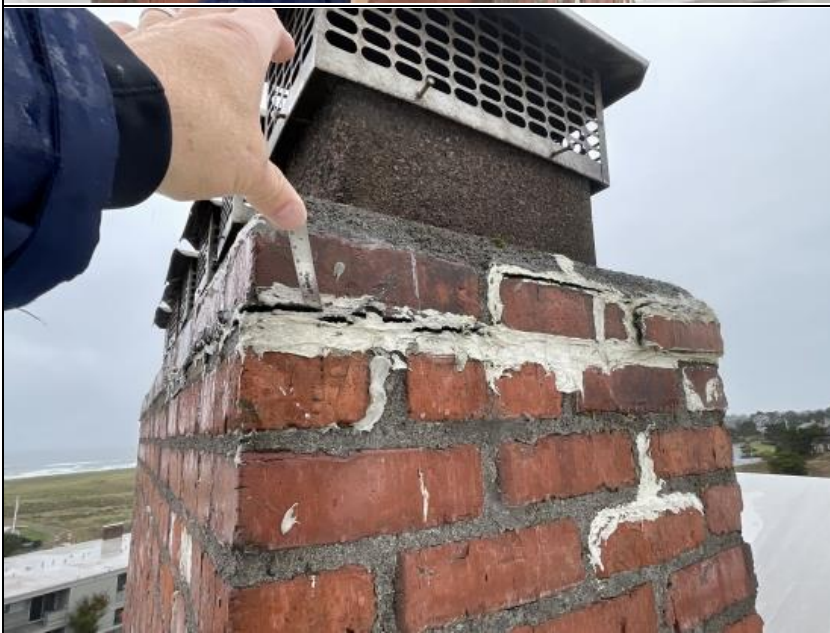
**Description:** Several penetrations and integration points are sealant dependent, and the sealant is deteriorating.

**Photo Information:**  
**Building #**N/A, **Unit #**N/A  
**Elevation:** East  
**Photo Notes:** Sealant is incorrectly used and is failing at mortar joints  
**Photo Date:** 10/21/2022

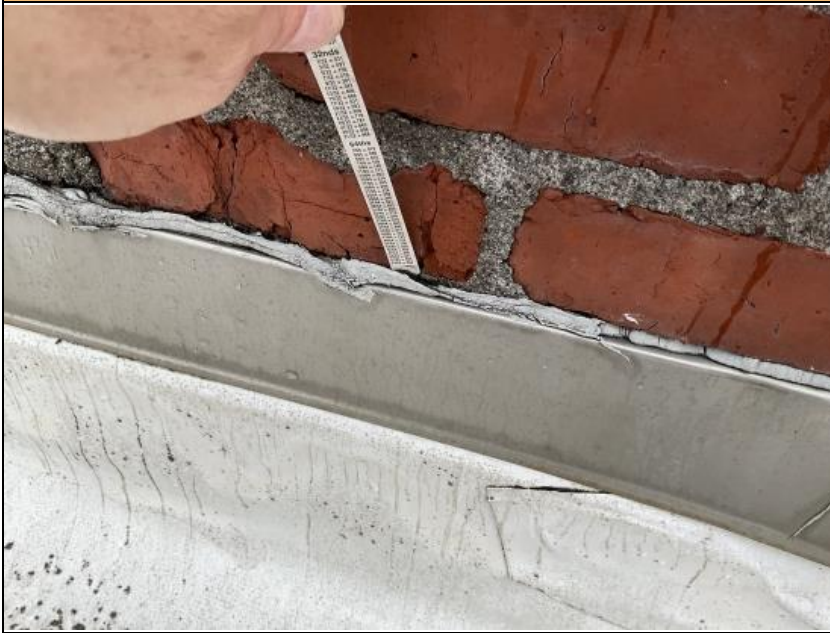
**Building #**N/A, **Unit #**N/A

**Photo Notes:** Failed sealant at base of brick counterflashing over roof membrane

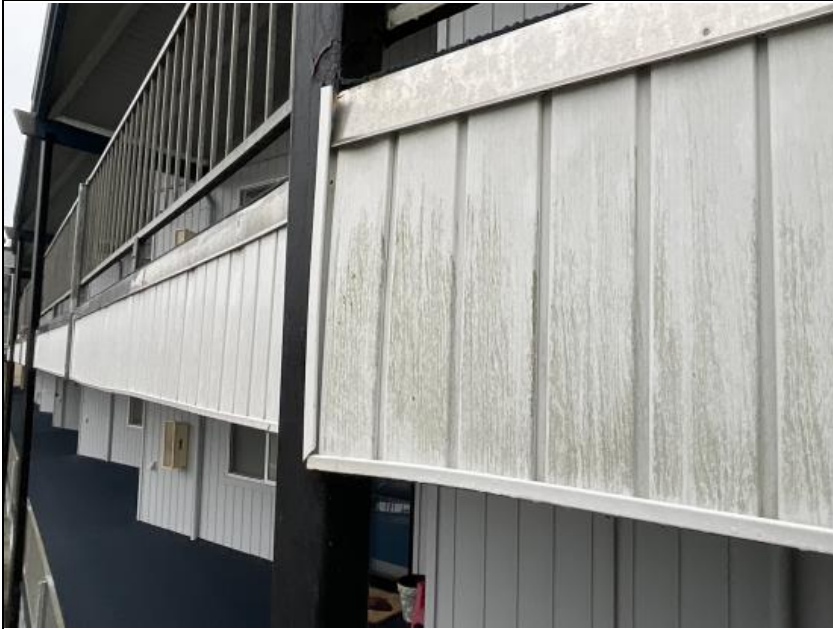
**Building #**N/A, **Unit #**N/A

**Description:** Water damaged cladding and components.

**Photo Notes:** Vinyl siding showing signs of deterioration and is likely hiding further damage.

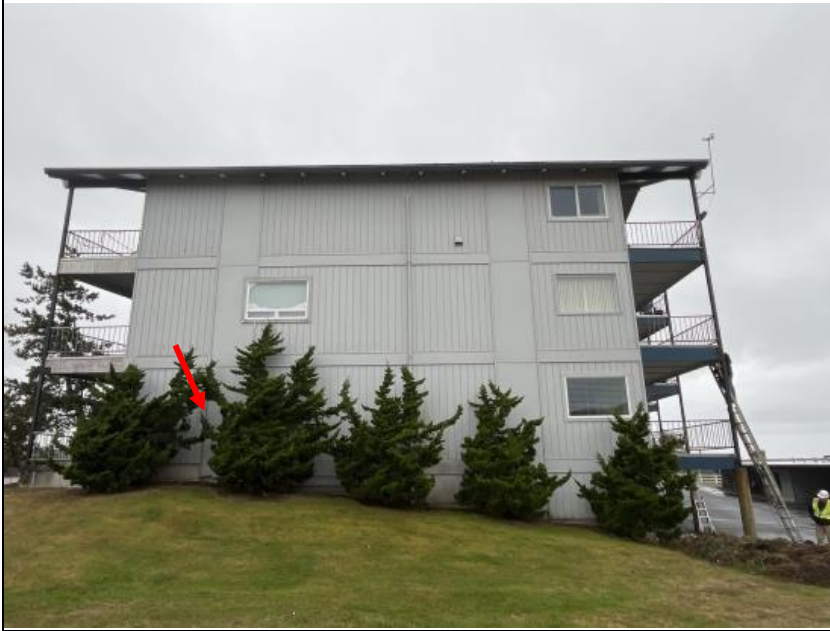
**Building #**N/A, **Unit #**N/A

**Photo Notes:** Damage to panel siding in several locations.

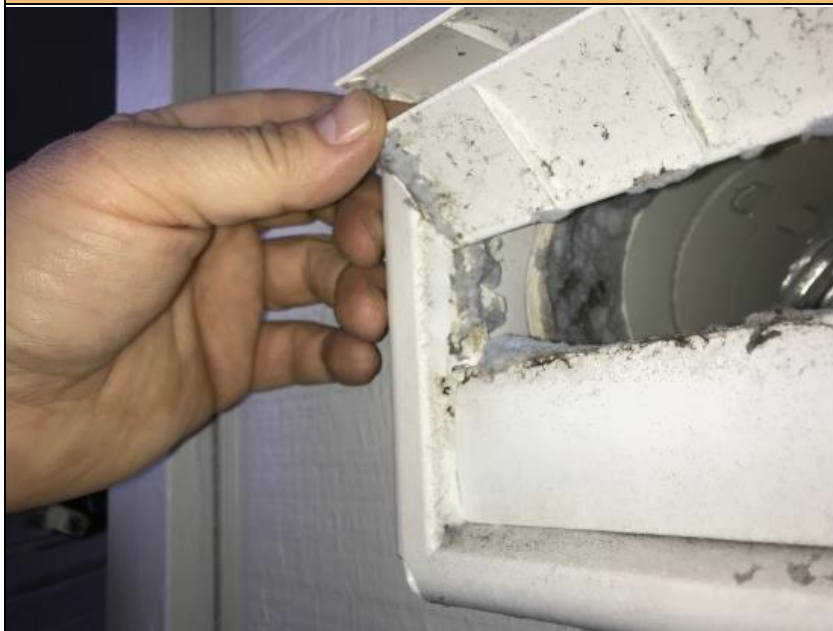
**Building #1238, Unit #N/A**

**Description:** Omitted flashings at wall penetrations. Dryer vents were also observed to not be tight lined and incorrectly have screens that trap lint.

**Photo Notes:** Dryer vent terminates inside the wall cavity and traps lint presenting a potential fire hazard.

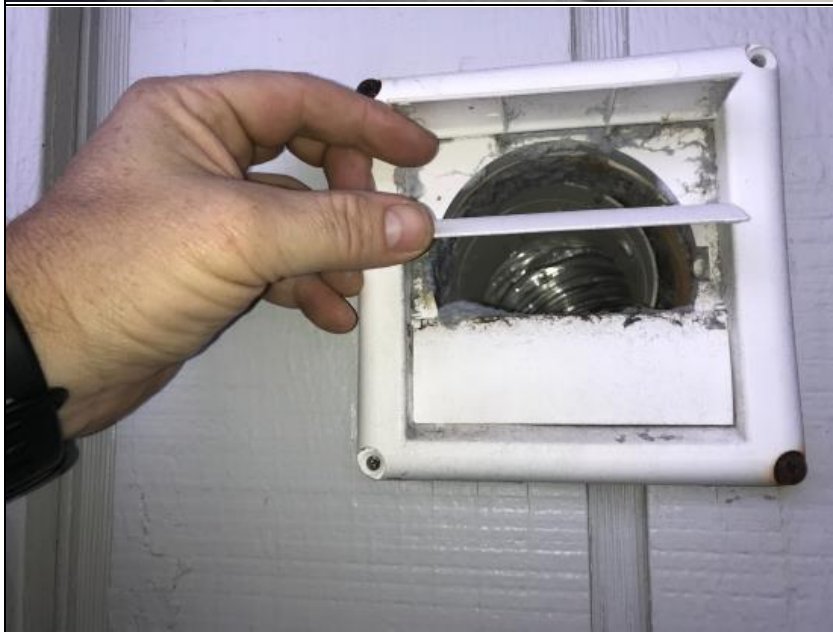
**Building #1238, Unit #N/A**

**Photo Notes:** Dryer vent pipe is flexible and not hard pipe, so lint is easily trapped presenting potential fire hazard.

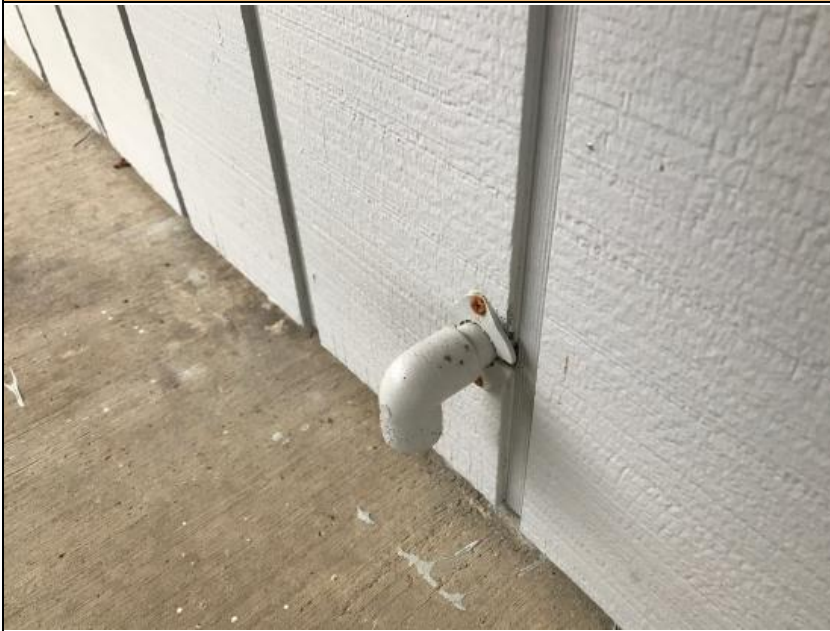
**Building #1238, Unit #467**

**Photo Notes:** Sealant dependent wall penetration; note corrosion at fasteners.

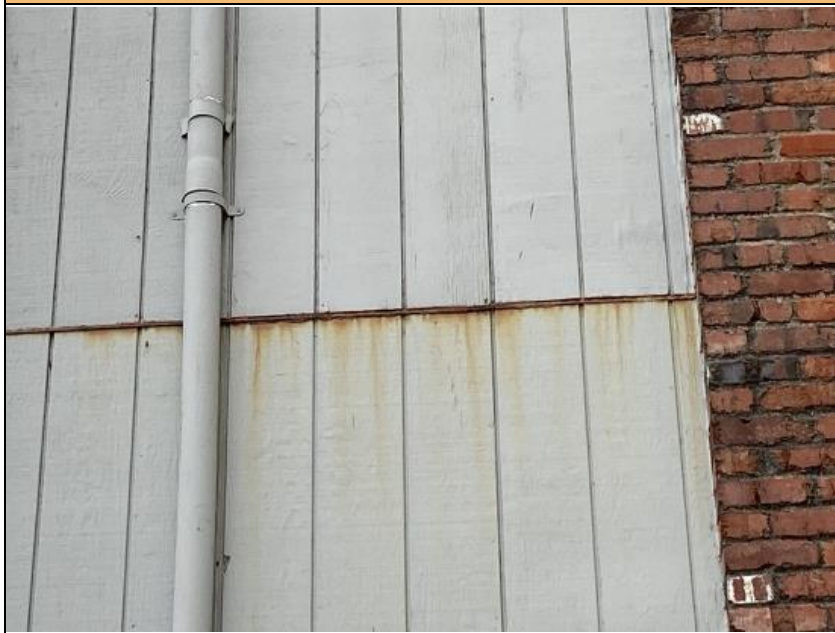
**Building #1238, Unit #N/A**

**Description:** Corrosion at sheet metal flashing located at siding panel breaks.

**Photo Notes:** Corroded metal flashing

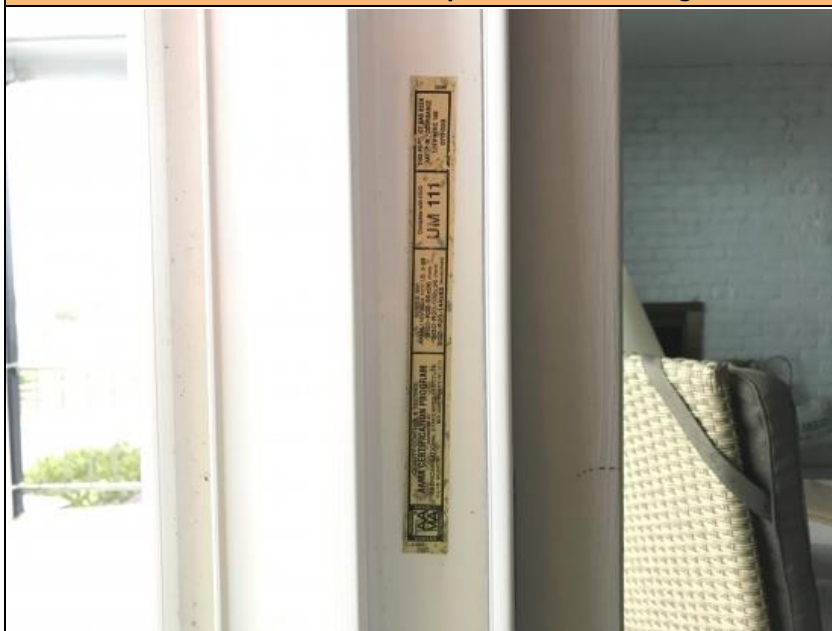
**Building #1238, Unit #479**

**Description:** J2 observed several window AAMA Gold Labels in sliding glass door and window units. While there are many varying performance grades noted, in all cases the performance ratings appear to be significantly less than what is required to resist code required loading.

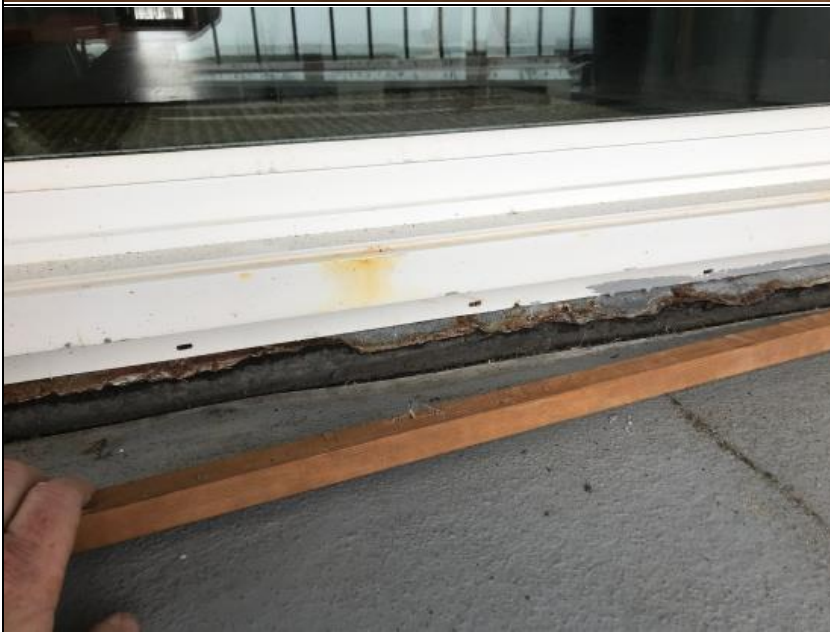
**Building #1238, Unit #479**

**Description:** Corroded sill pans at sliding glass doors on the buildings West face.

**Photo Notes:** Sill pan has completely corroded away.

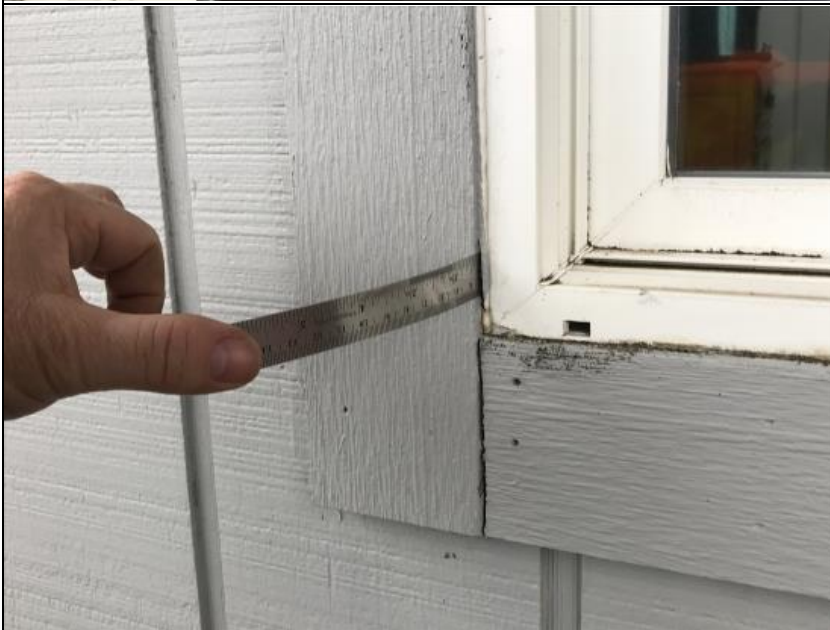
**Building #1238, Unit #485**

**Description:** Omitted dynamic sealant joints. Window frames are installed tight to wood trim which does not allow proper expansion/contraction. Sealant is failing.

**Photo Notes:** Failed sealant joint; window frame tight to trim

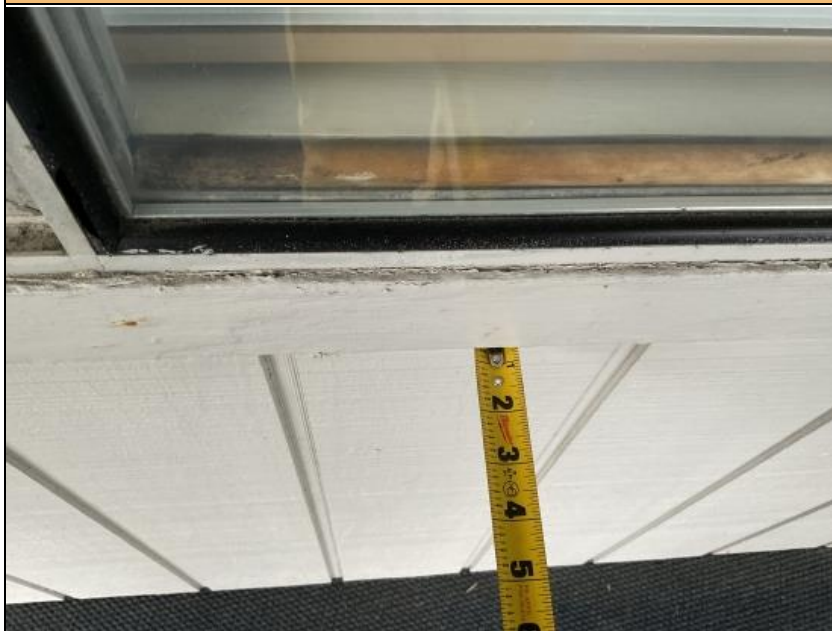
**Photo Information:**  
**Building #**N/A, **Unit #**N/A  
**Elevation:** East  
**Photo Notes:** Failed sealant joint  
**Photo Date:** 10/21/2022

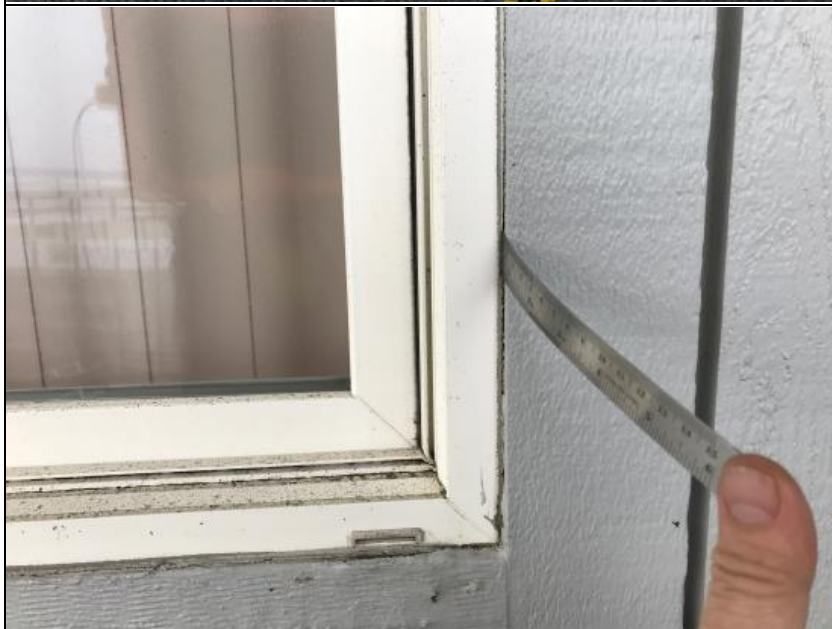
**Photo Information:**  
**Building #**1238, **Unit #**484  
**Elevation:** West  
**Photo Notes:** Failed sealant joint; window frame tight to trim  
**Photo Date:** 10/21/2022

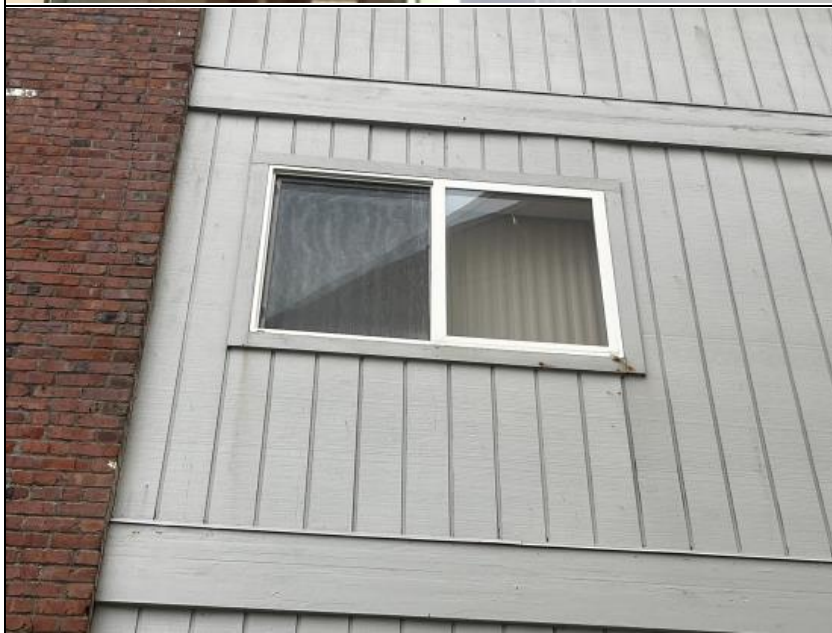
**Building #1238, Unit #N/A**

**Description:** Failed IGU (Insulated Glass Units); Moisture observed between window glazing panels.

**Photo Notes:** Fogged windows (failed IGU)

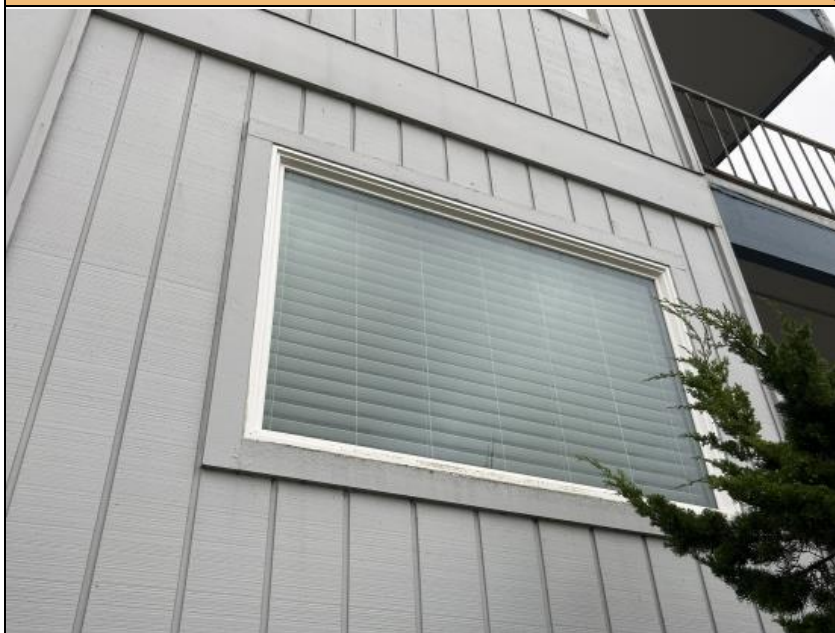
**Building #N/A, Unit #N/A**

**Photo Notes:** Fogged windows (failed IGU)

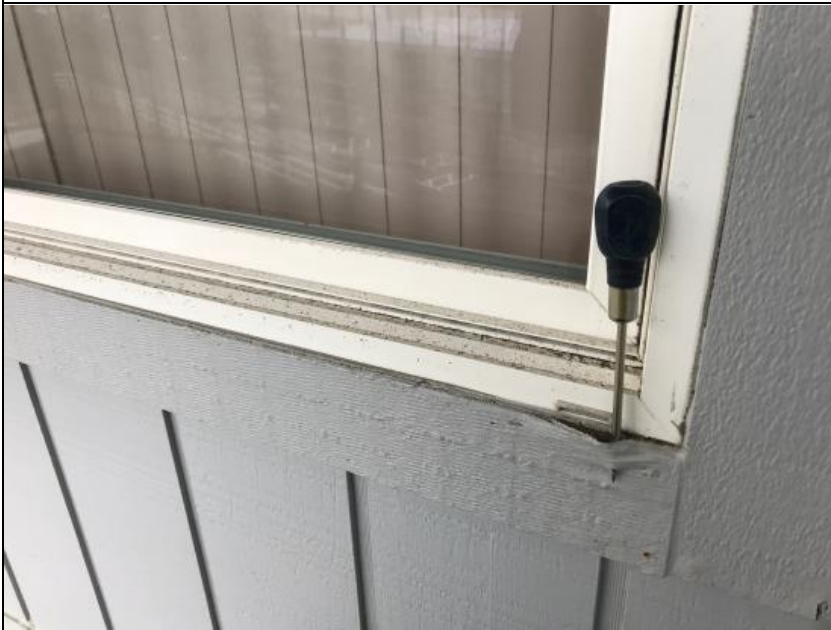
**Building #1238, Unit #484**

**Photo Notes: Water damaged window trim**

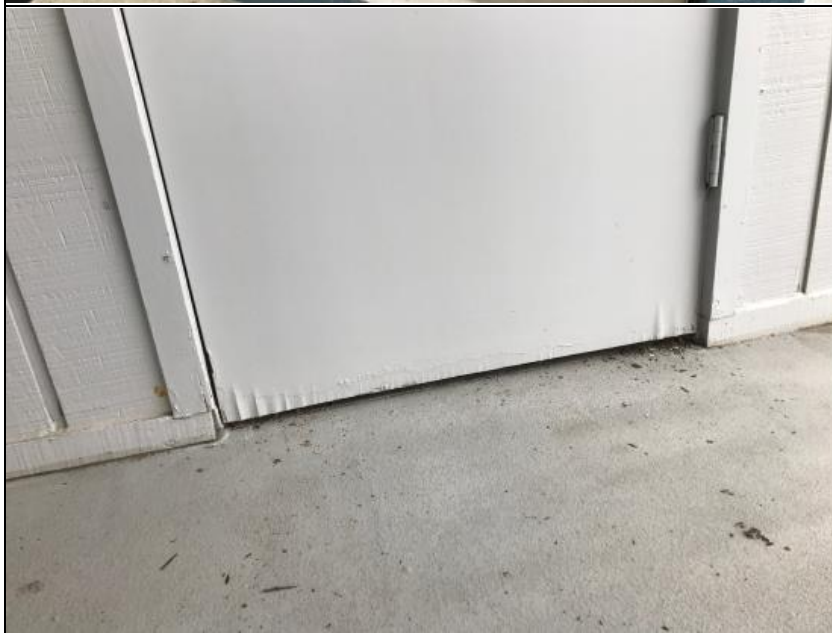
**Building #1238, Unit #484**

**Description:** Water damaged and delaminating swing doors at several locations on the East & West building face.

**Photo Notes:** Water damaged wood panel door

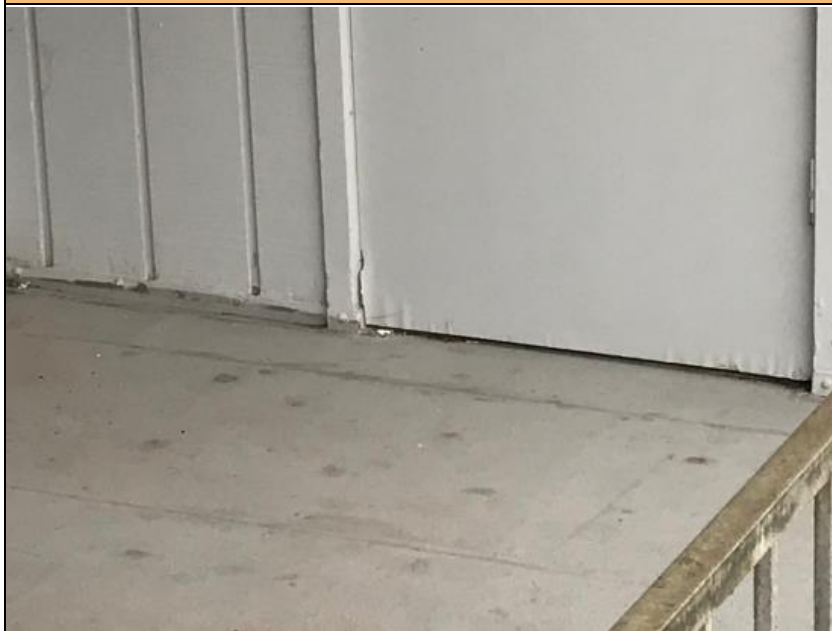
**Building #1238, Unit #476**

**Photo Notes:** Water damaged wood panel door

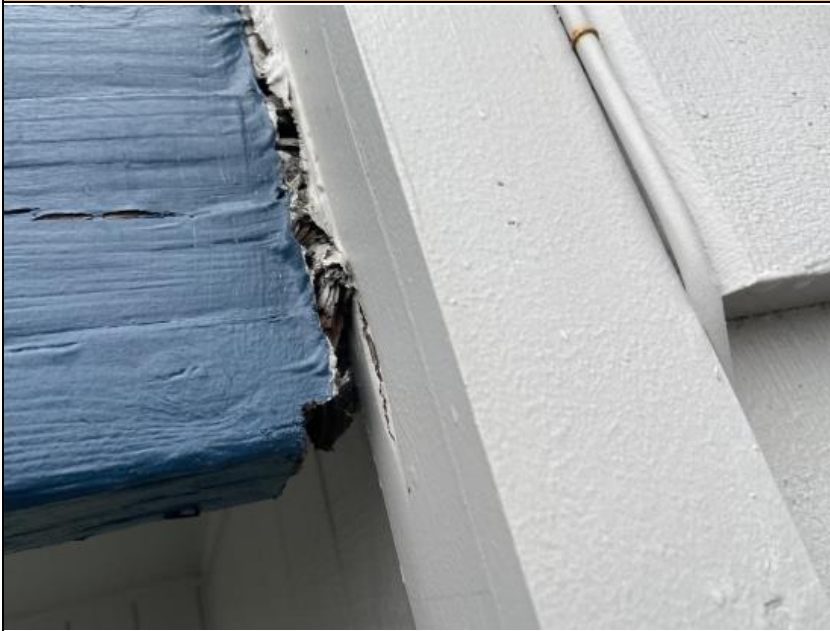
**Building #1238, Unit #N/A**

**Description:** Water damage at deck and walkway beams.

**Photo Notes: Water damaged wood beam**

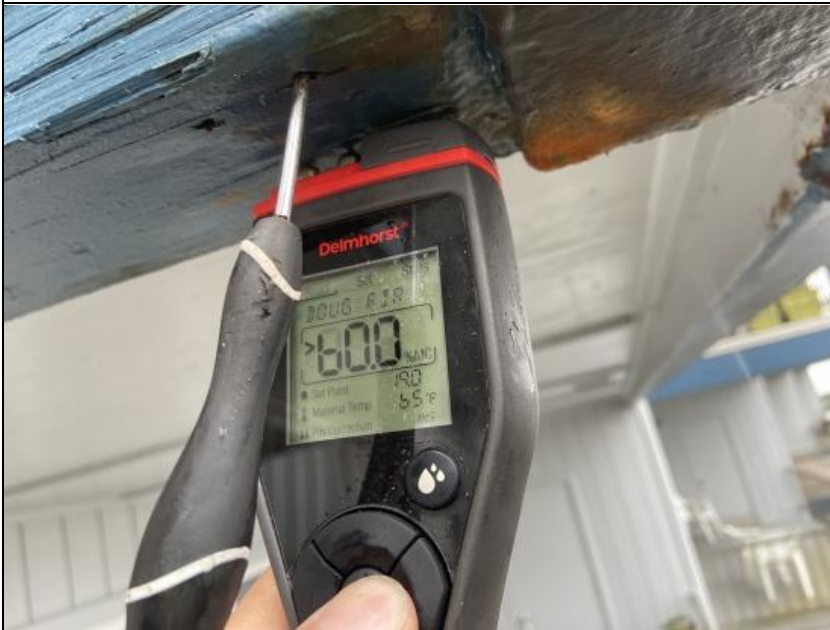
**Building #1238, Unit #481**

**Photo Notes: Water damaged wood beam**

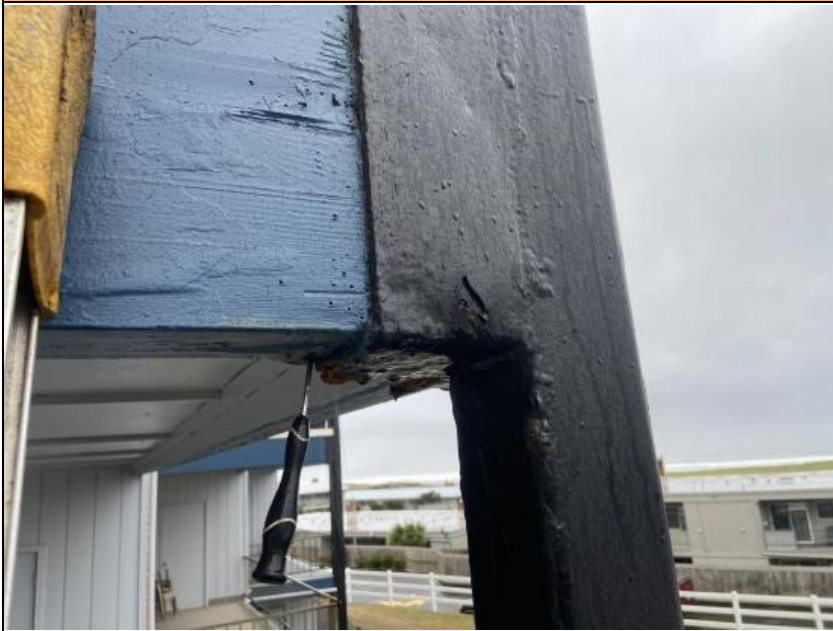
**Building #1238, Unit #N/A**

**Photo Notes: Water damaged wood beam**

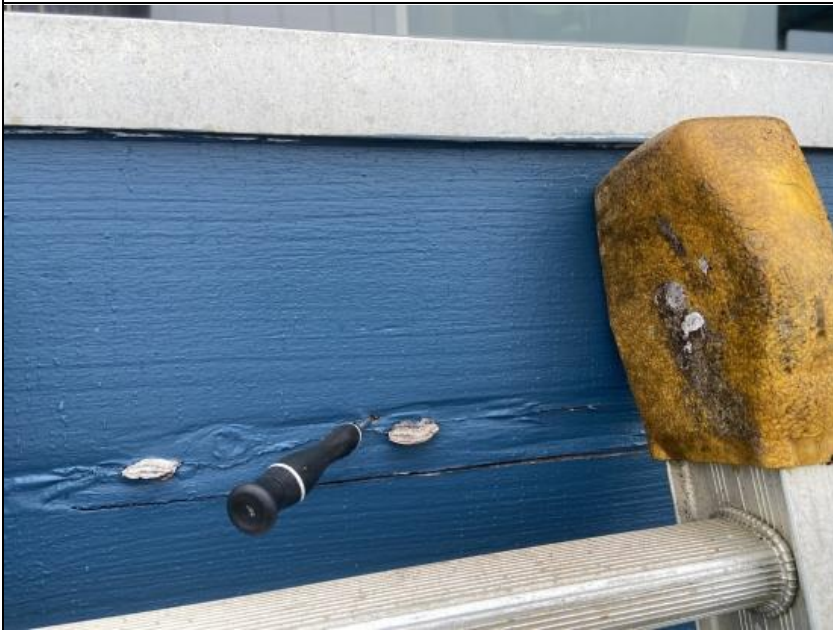
**Building #1238, Unit #479**

**Photo Notes: Water damaged wood beam**
