# PACIFIC VIEW CONDOMINIUMS

## Preliminary Building Envelope and Limited Structural Observations

**Address:** 128 N Marion Ave, Gearhart, OR 97138

**Date:** November 22, 2022

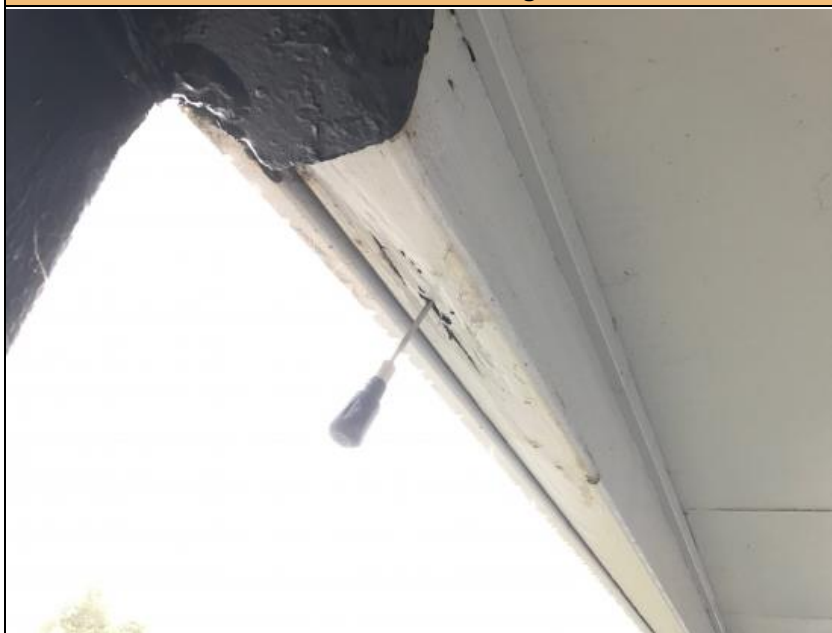
**Building #1238, Unit #N/A**

**Photo Notes:** Water damaged wood beam

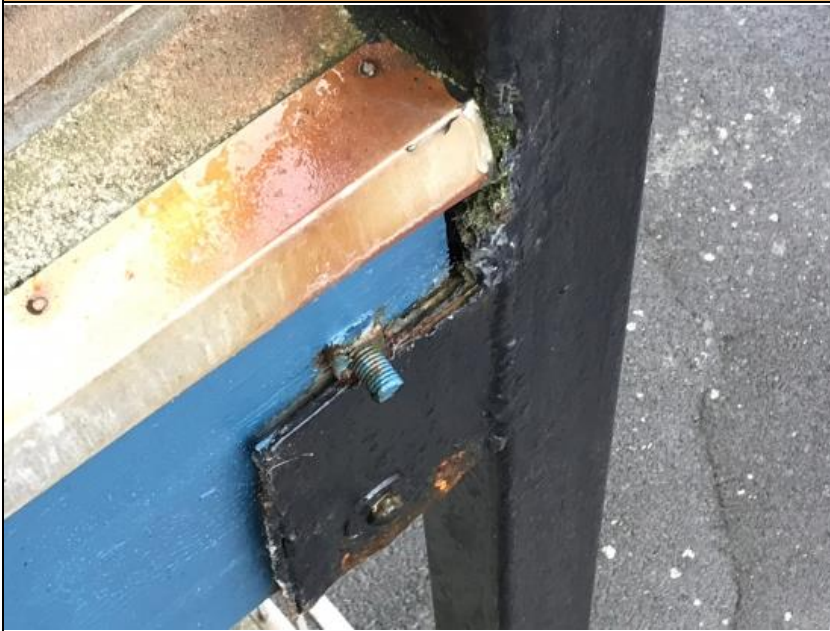
**Building #1238, Unit #479**

**Description:** Corrosion and damage in structural steel framing.

**Photo Notes:** Water damaged steel column and bracket

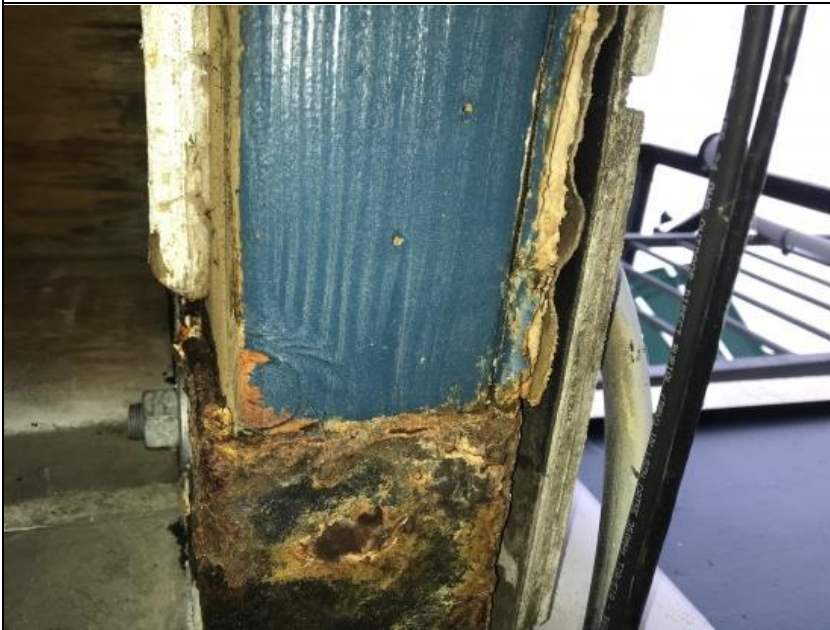
**Building #1238, Unit #N/A**

**Photo Notes:** Water damaged steel column and bracket

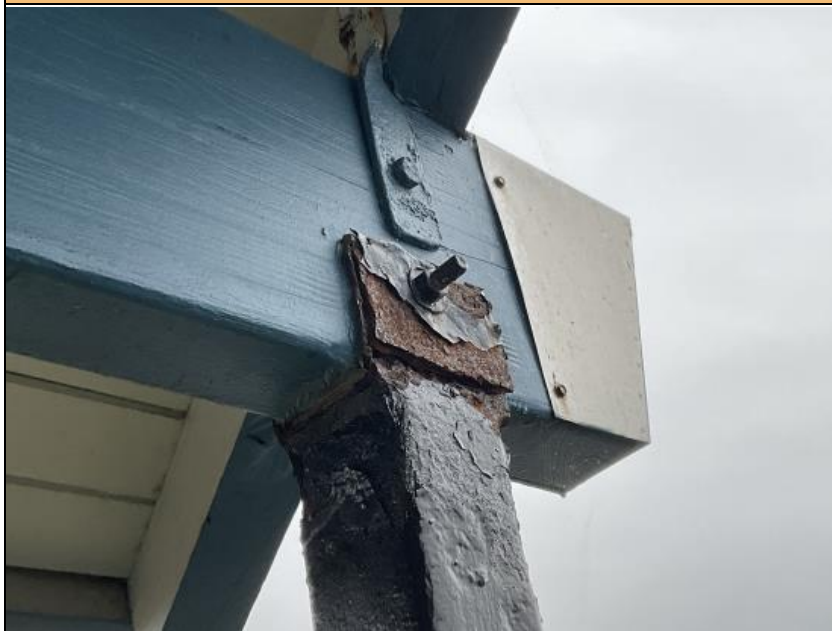
**Building #**N/A, **Unit #**N/A

**Photo Notes:** Water damaged steel column and bracket

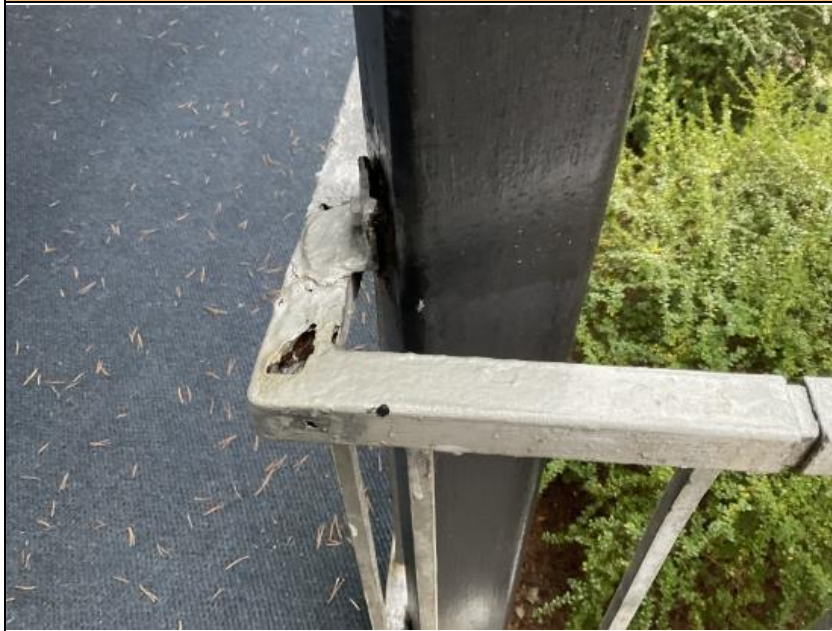
**Description:** Corrosion at guardrail components.

**Photo Information:**  
**Building #**N/A, **Unit #**N/A  
**Elevation:** East  
**Photo Notes:** Corrosion at metal railing  
**Photo Date:** 10/21/2022

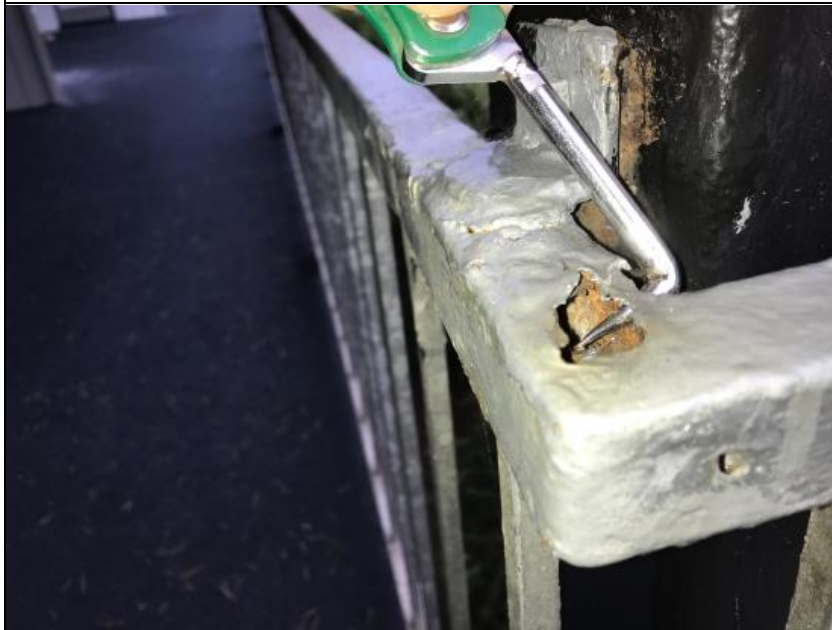
**Photo Information:**  
**Building #**1238, **Unit #**N/A  
**Elevation:** South East  
**Photo Notes:** Corrosion at metal railing  
**Photo Date:** 10/21/2022

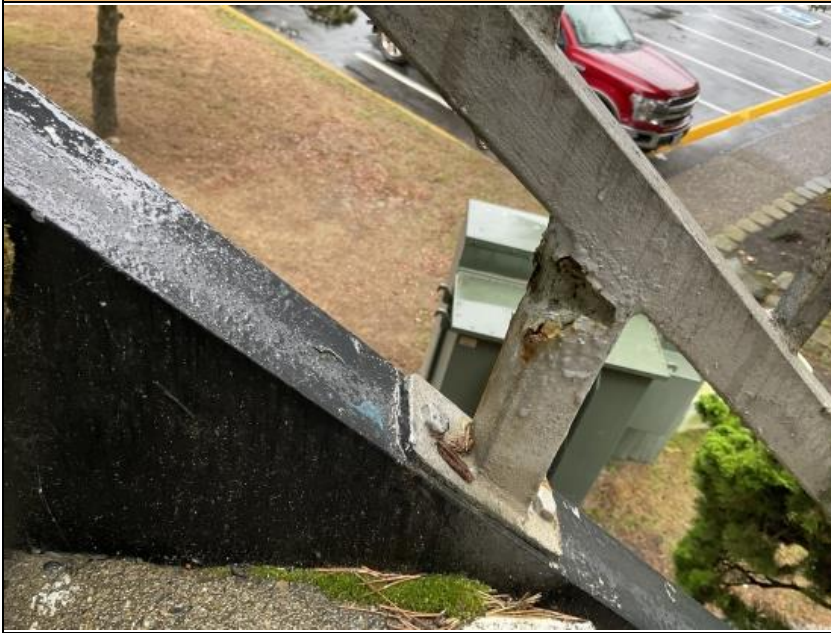
**Building #**N/A, **Unit #**N/A

**Photo Notes:** Corrosion at metal railing

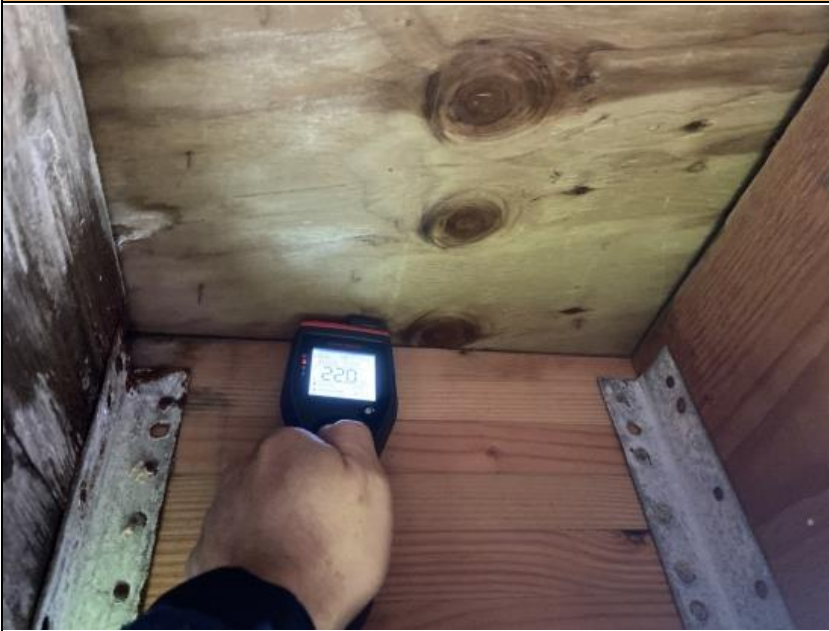
**Building #1238, Unit #N/A**

**Description:** Water damage to the wood structure was observed beneath the waterproofing at many deck and entryway locations.

**Photo Notes:** Water damaged deck sheathing

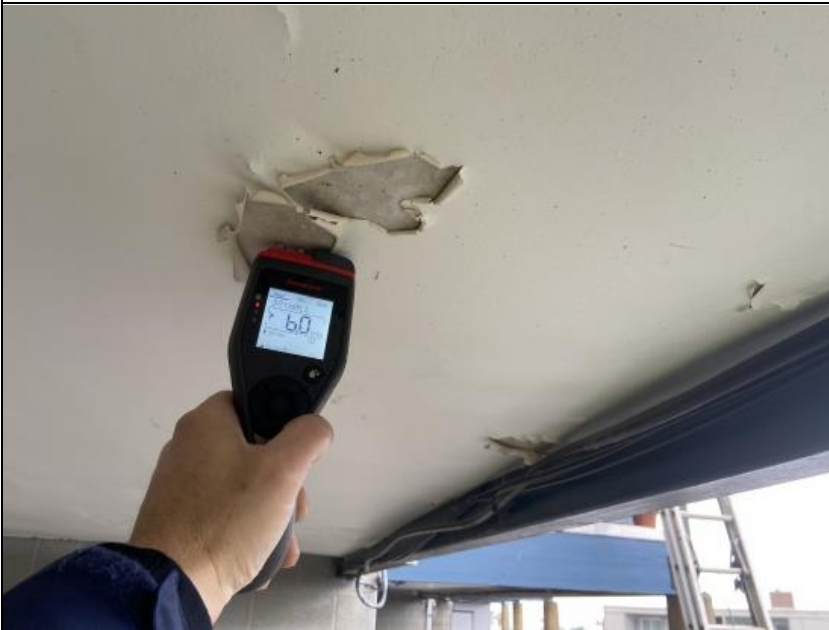
**Building #1238, Unit #N/A**

**Photo Notes:** Water damaged deck soffit

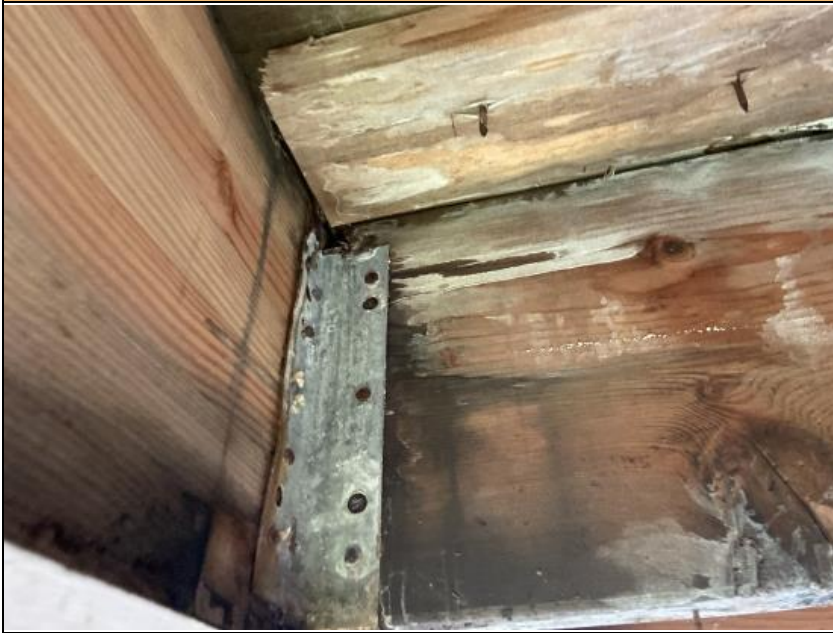
**Building #1238, Unit #N/A**

**Photo Notes: Water damaged deck framing**

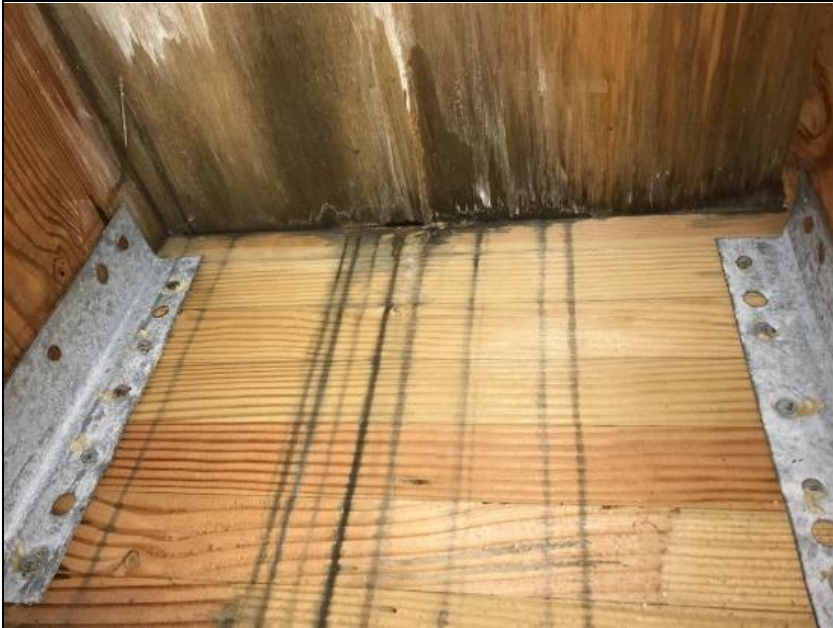
**Building #1238, Unit #N/A**

**Photo Notes: Water damaged deck sheathing**

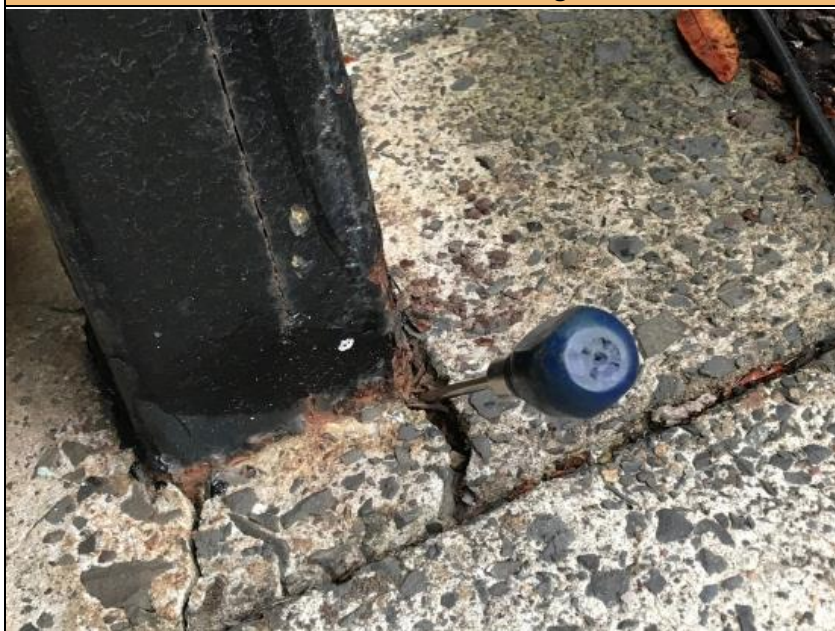
**Building #1238, Unit #N/A**

**Description:** Concrete damage was observed at footings supporting steel columns and at structural concrete columns.

**Photo Notes:** Cracked concrete at base of steel column; apparent incorrectly detailed closure pour

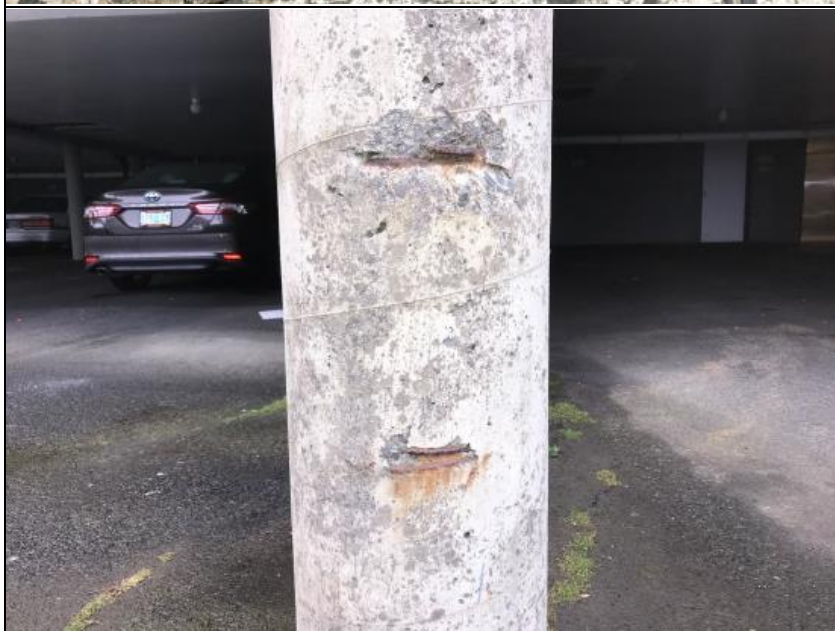
**Building #1238, Unit #N/A**

**Photo Notes:** Spalling and rebar corrosion at concrete column

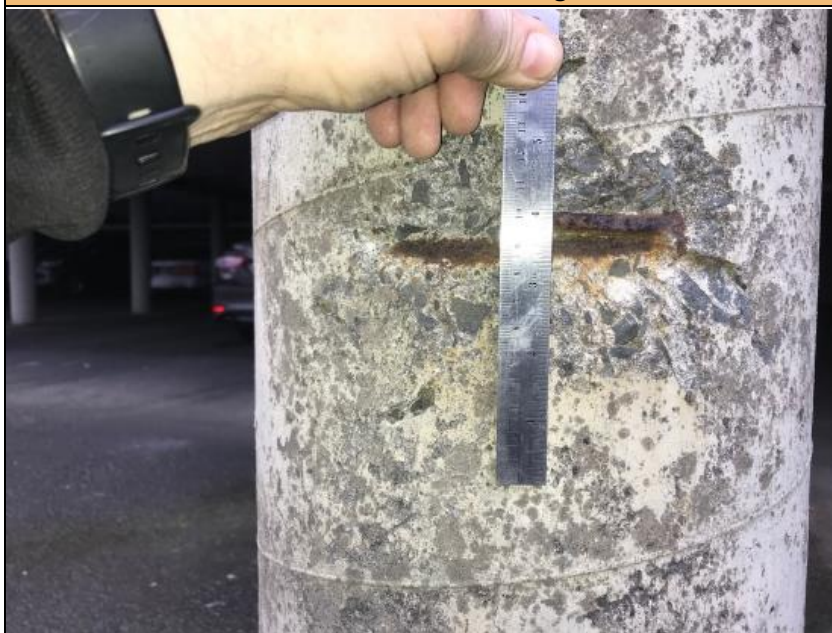
**Building #1238, Unit #N/A**

**Photo Notes:** Spalling and rebar corrosion at concrete column

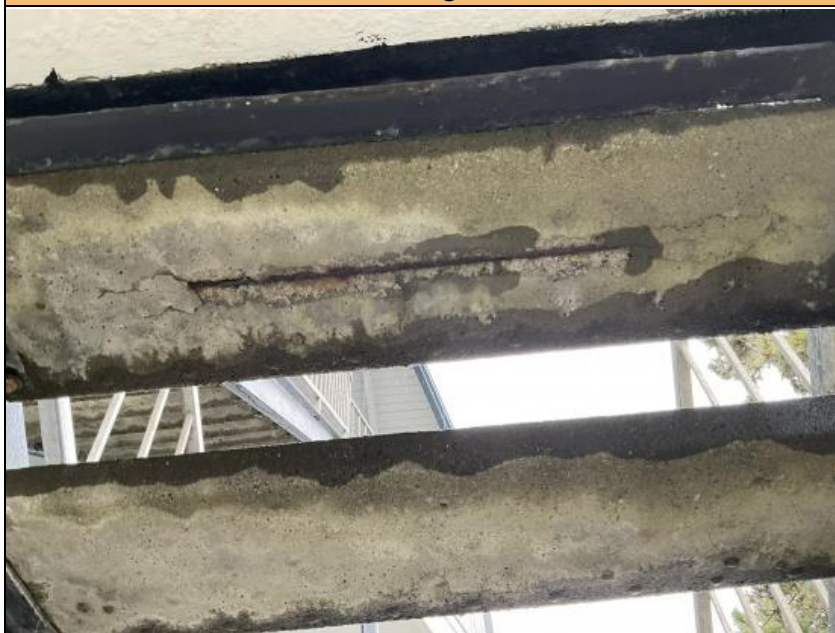
**Building #**N/A, **Unit #**N/A

**Description:** Stair treads have cracking and/or exposed reinforcing steel.

**Photo Notes:** Cracking/spalling at concrete stair tread

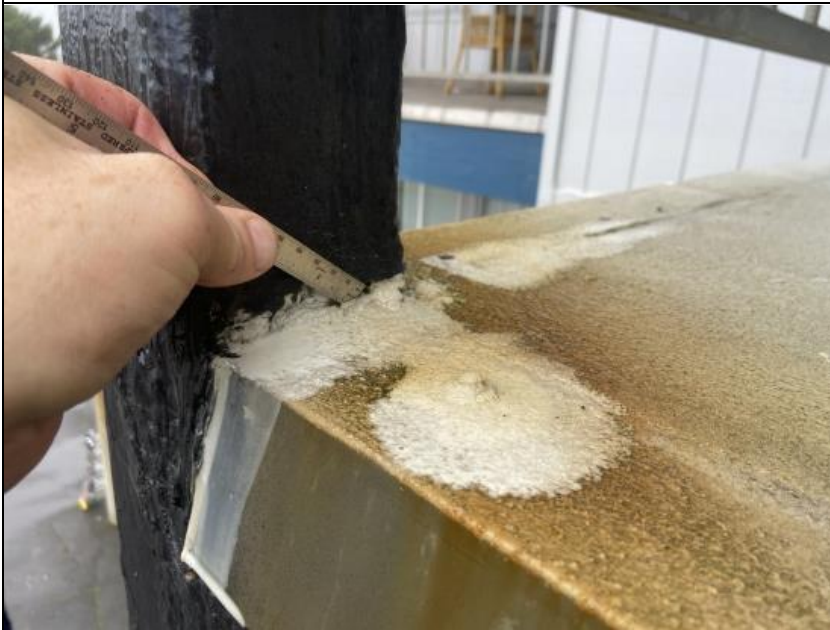
**Building #N/A, Unit #N/A**

**Description:** Cracked, failing and adhesion failures on deck coatings.

**Photo Notes:** Sealant dependent joint; failed sealant at deck transitions

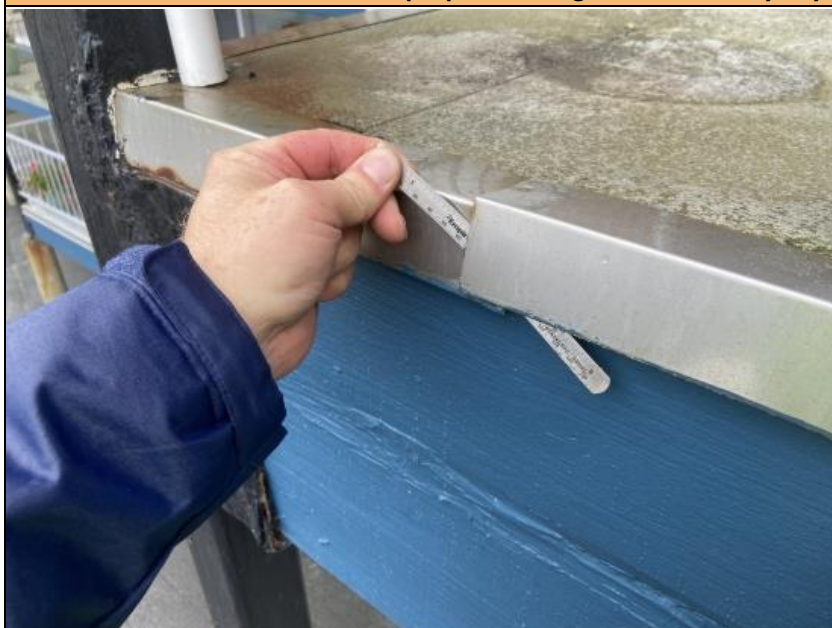
**Building #1238, Unit #479**

**Description:** Improperly lapped and unsealed drip edge flashing

**Photo Notes:** Improper overlap and omitted sealant at deck perimeter flashing joint.

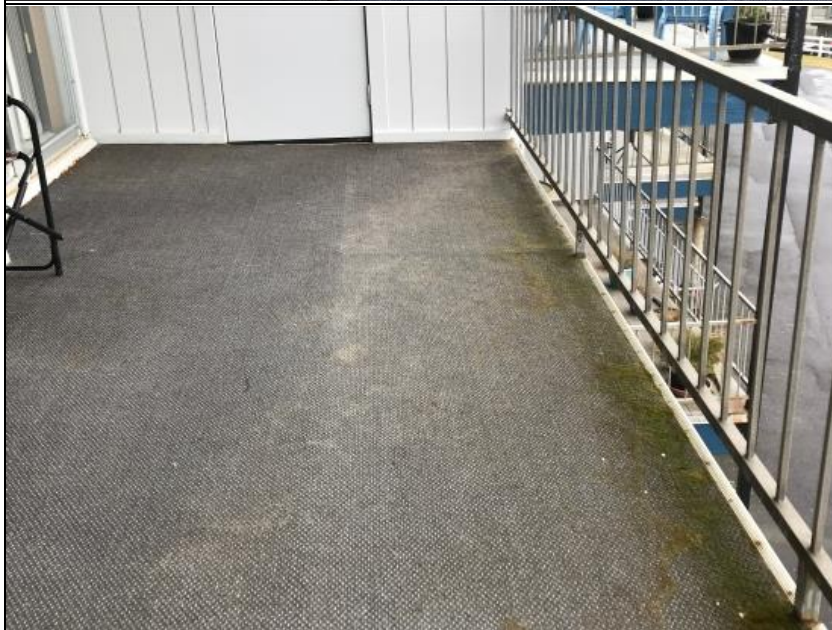
**Building #1238, Unit #485**

**Photo Notes:** Water stains at carpet

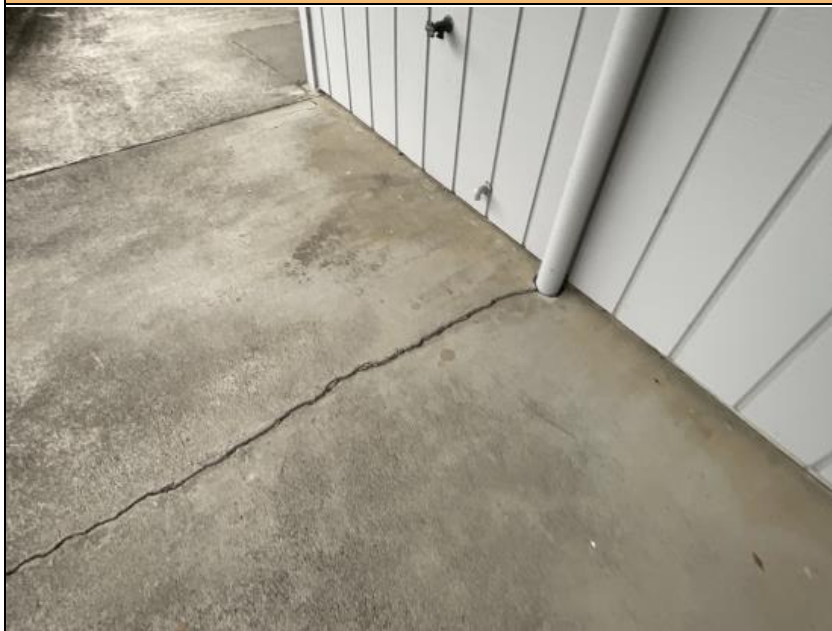
**Building #**N/A, **Unit #**N/A

**Photo Notes:** Concrete cracking starting at rain drain penetration
