# PACIFIC VIEW CONDOMINIUMS

## Preliminary Building Envelope and Limited Structural Observations

**Address:** 128 N Marion Ave, Gearhart, OR 97138

**Date:** November 22, 2022

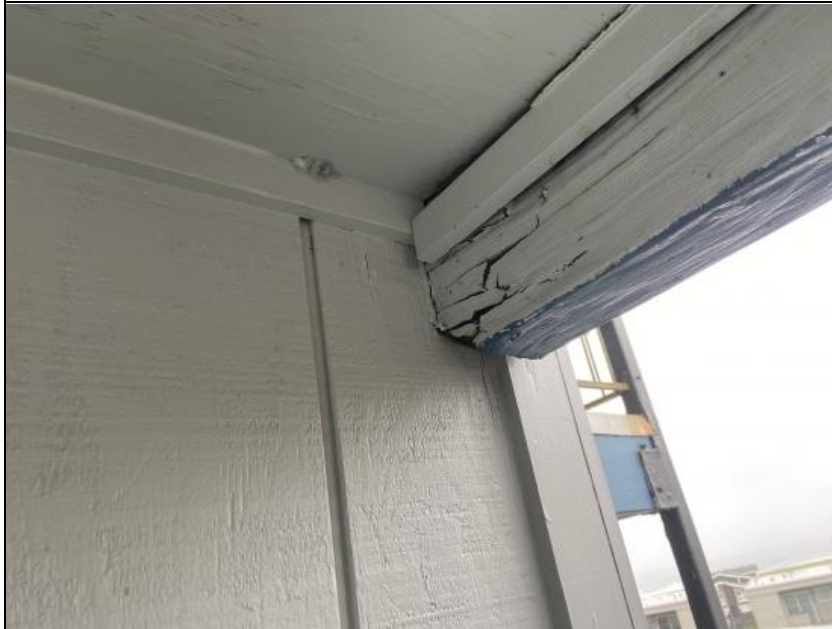
**Building #1238, Unit #479**

**Description:** Structural deck beams are severely water damaged and are unsafe to support code required loads.

**Photo Notes:** Water damaged deck support beam.

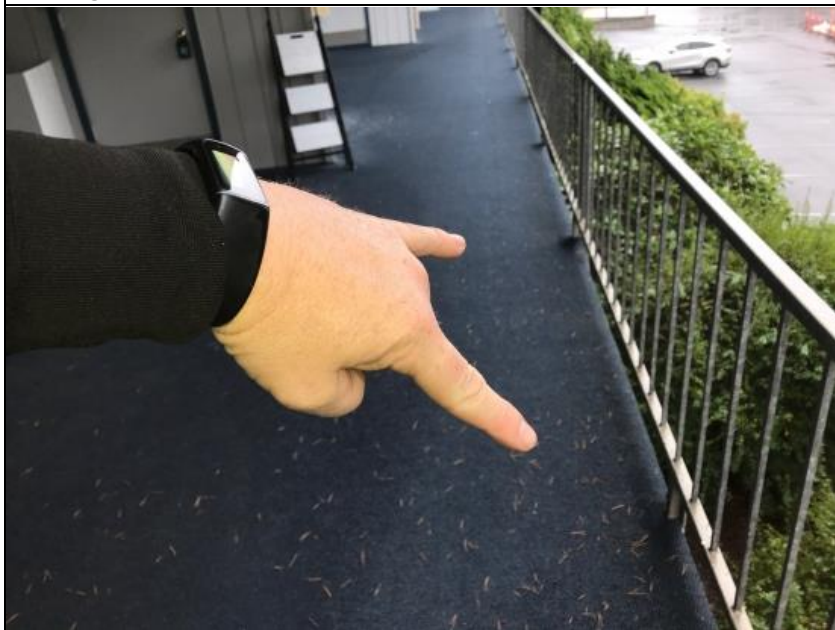
**Building #1238, Unit #483**

**Description:** Guardrails are loosely attached to the building and may not support code required loading.

**Photo Notes:** Loose guardrail connection at the walkway adjacent to unit #483.

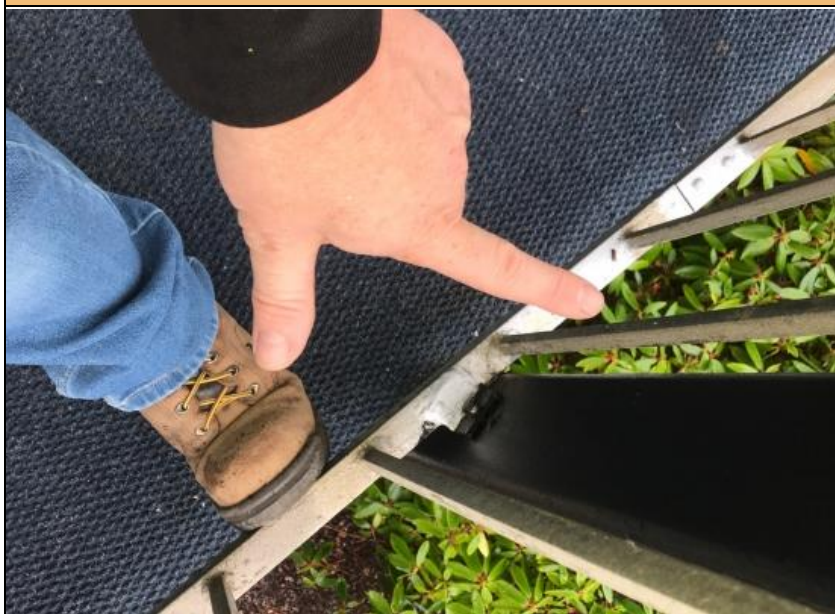
**Building #1238, Unit #483**

**Photo Notes:** Loose guardrail connection

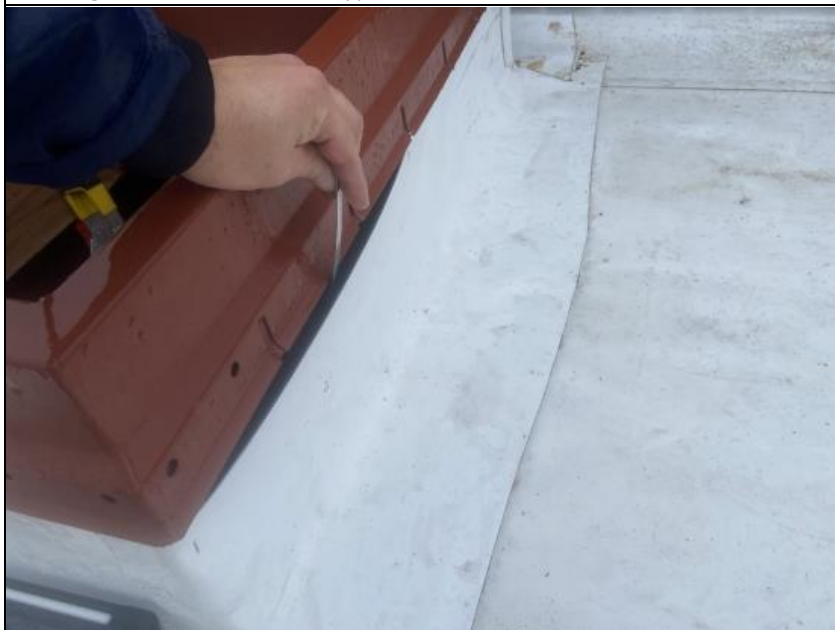
**Description:** J2 observed water damaged building components and improper installation methods at critical integration areas with the membrane.

**Photo Notes:** Roofing membrane not properly lapped at roof access hatch.

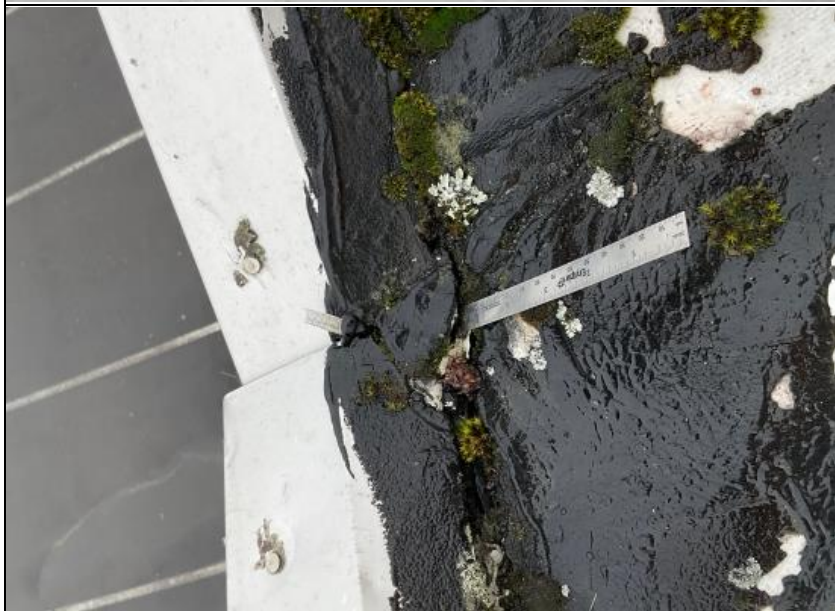
**Building #N/A, Unit #N/A**

**Photo Notes:** Failed sealant at valley termination, allows water on framing member. Damage documented below.

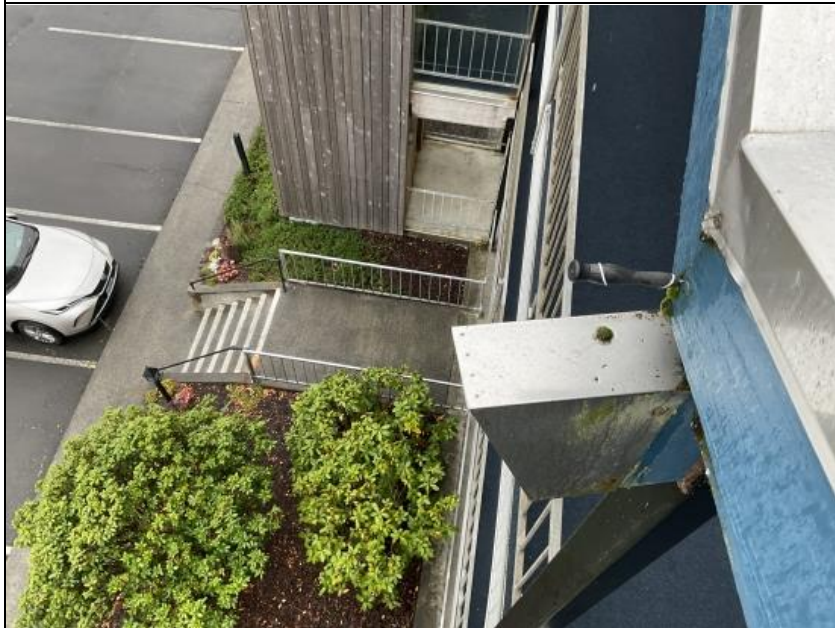
**Building #**N/A, **Unit #**N/A

**Description:** Mis-lapped and missing drip edge flashing at roof perimeter contributing to water damaged barge rafter and beams.

**Photo Notes:** Water damaged barge rafter.

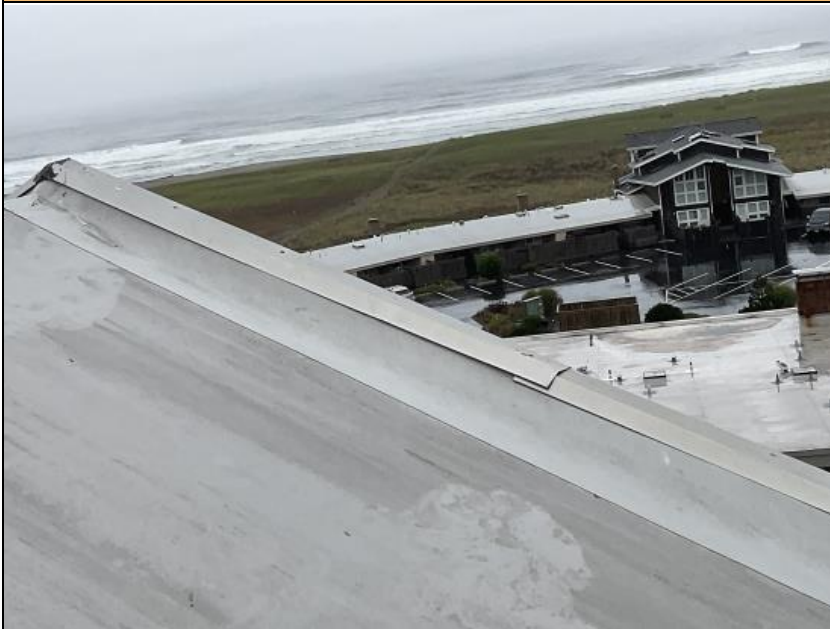
**Elevation:** East

**Photo Notes:** Inadequate flashing overlap; flashing is top fastened

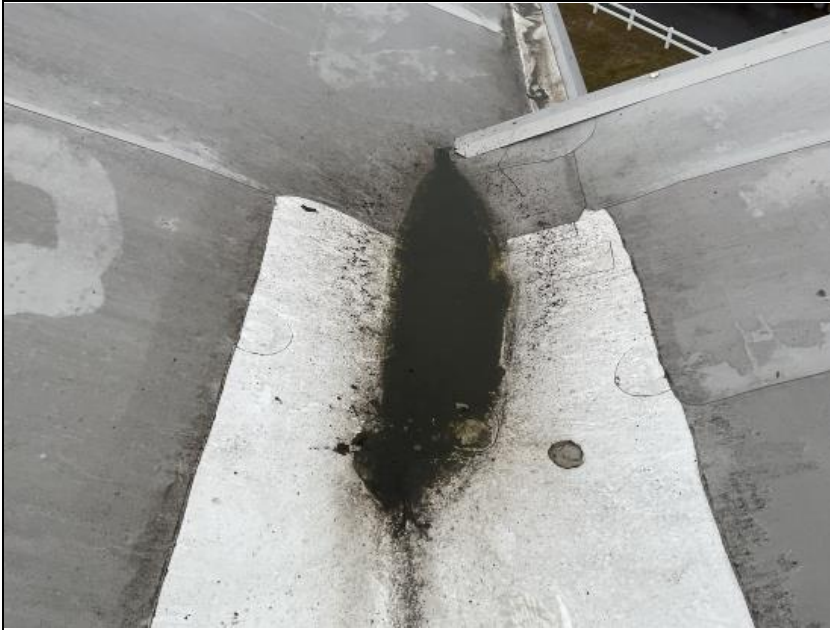
**Building #**N/A, **Unit #**N/A

**Description:** Ponding due to inadequate slope at valleys and waterways occurs at some locations

**Photo Notes:** Ponding water and soil deposits at end of valley

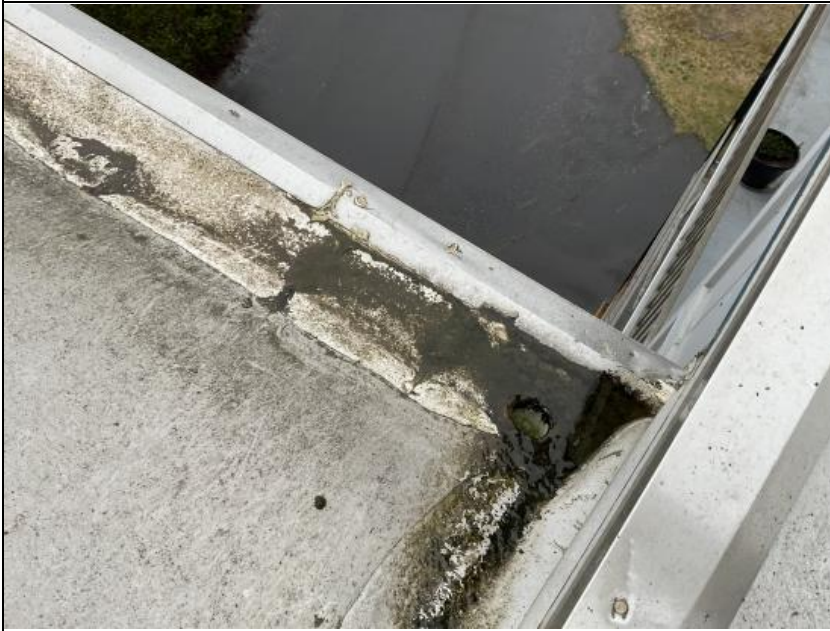
**Building #**N/A, **Unit #**N/A

**Photo Notes:** Water build up at roof edge; inadequate slope to intended roof drainage location

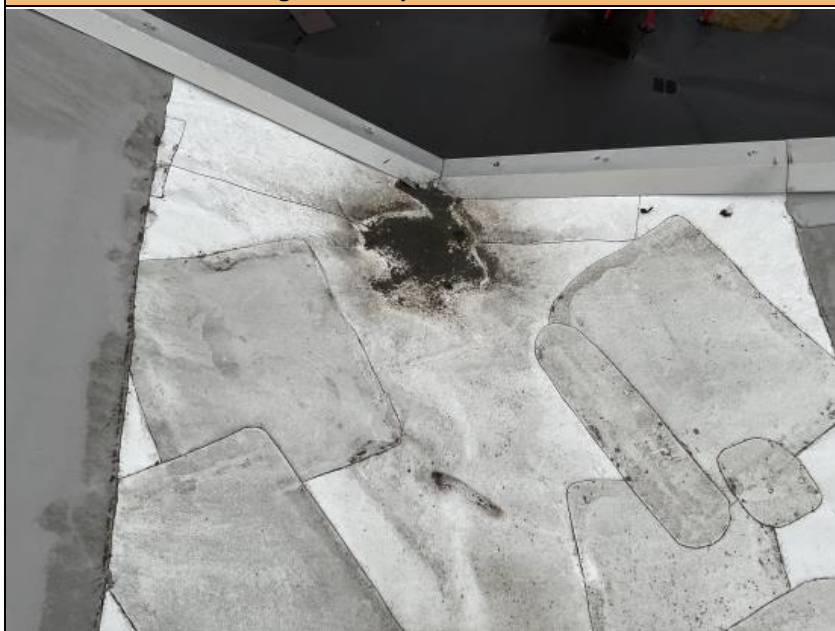
**Building #**N/A, **Unit #**N/A

**Photo Notes:** Water build up at roof edge;  
inadequate slope to intended roof drainage location

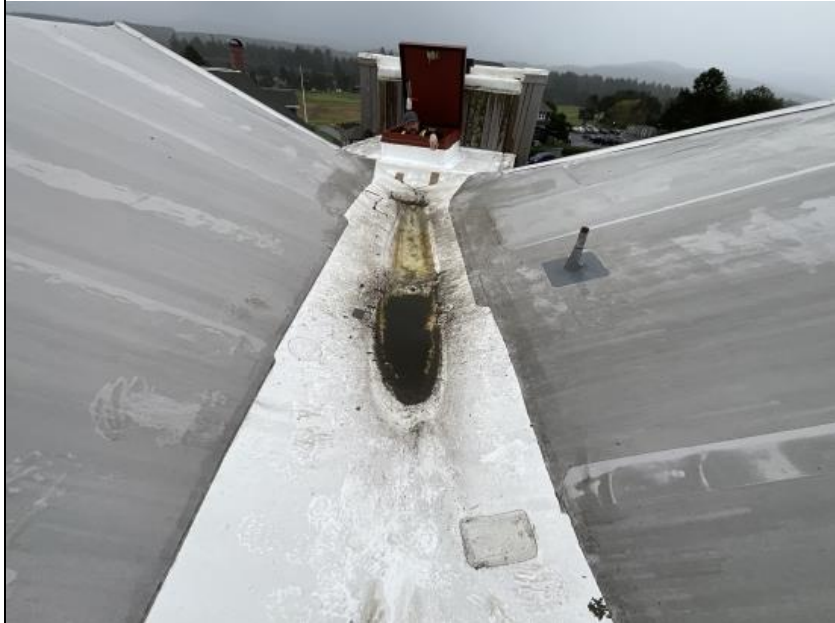
**Building #**N/A, **Unit #**N/A

**Photo Notes:** Roof valley appears to have  
inadequate slope for proper drainage; soil build-up

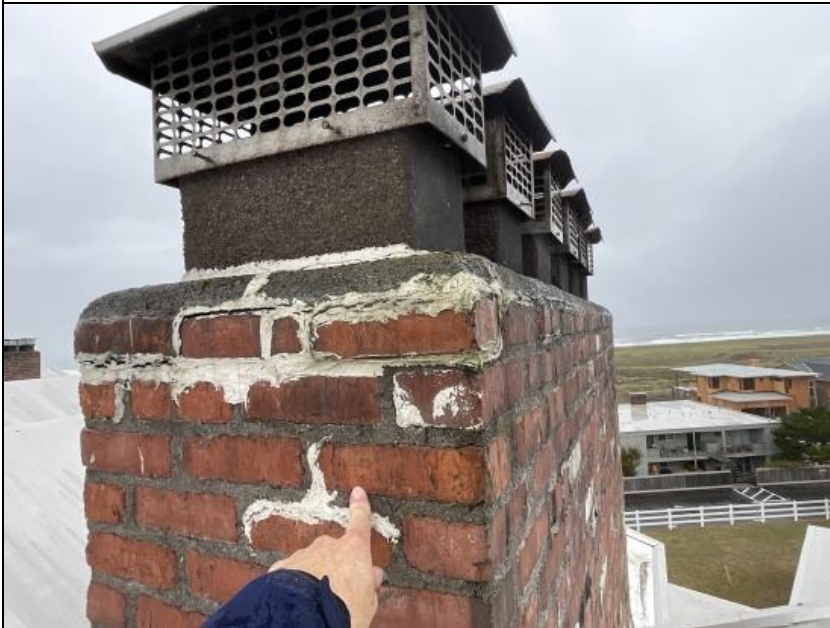
**Photo Information:**  
**Building #**N/A, **Unit #**N/A  
**Elevation:** East  
**Photo Notes:** Sealant is incorrectly used at mortar joints, as opposed to tuck pointing  
**Photo Date:** 10/21/2022

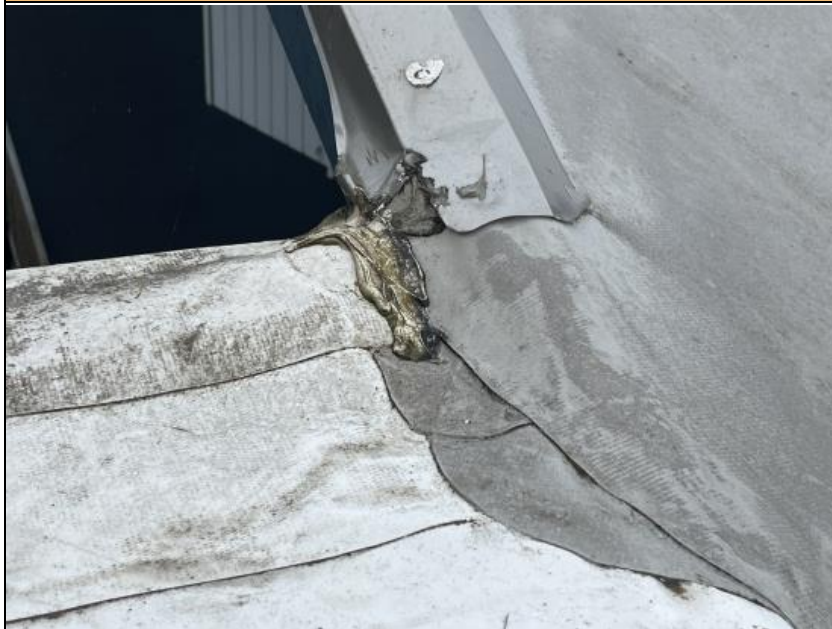
**Building #**N/A, **Unit #**N/A

**Photo Notes:** Omitted roof membrane and/or metal saddle; sealant dependent joint

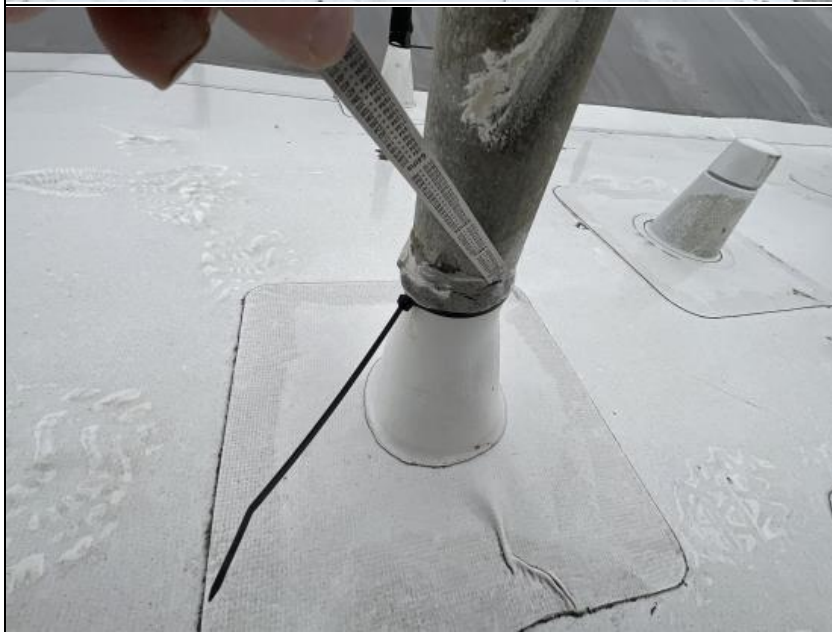
**Building #**N/A, **Unit #**N/A

**Photo Notes:** Failed sealant at roof penetration

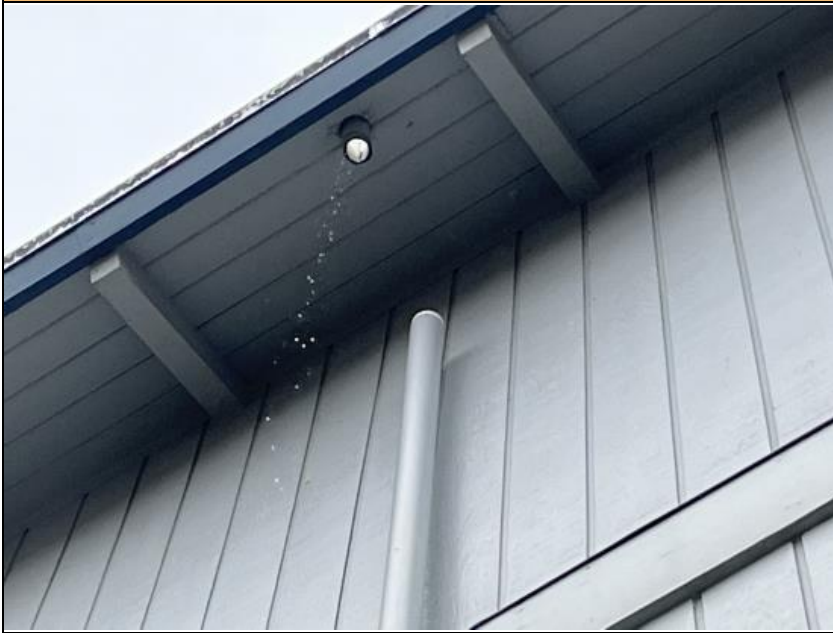
**Building #**N/A, **Unit #**N/A

**Photo Notes:** Close up of disconnected/missing downspout connection

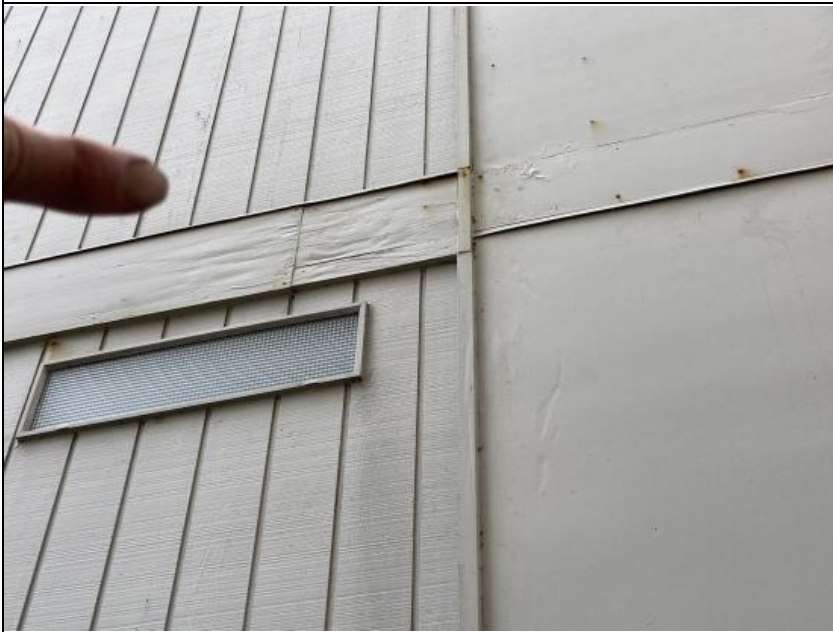
**Building #**1238, **Unit #**N/A

**Description:** Water damaged cladding and components.

**Photo Notes:** Water damaged bellyband at panel break.

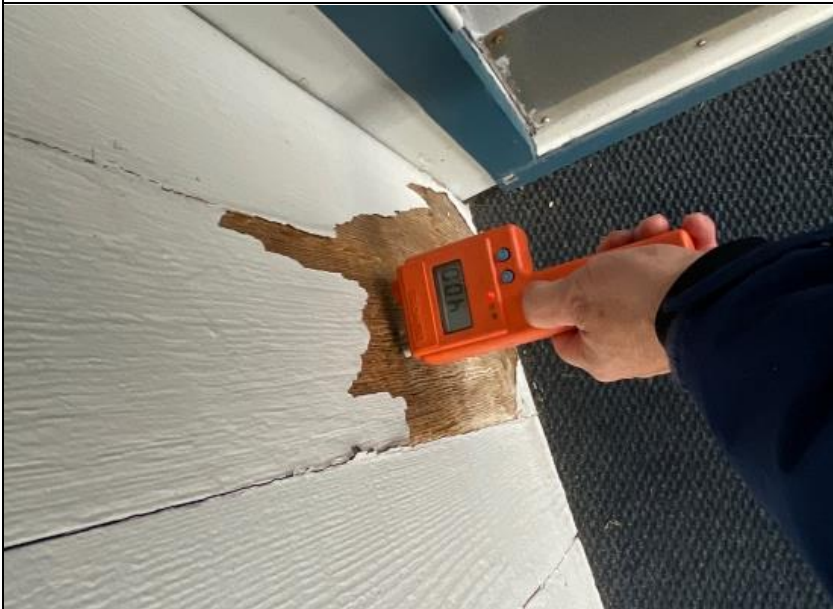
**Building #**N/A, **Unit #**N/A

**Photo Notes:** Water damaged siding under cover by doorway

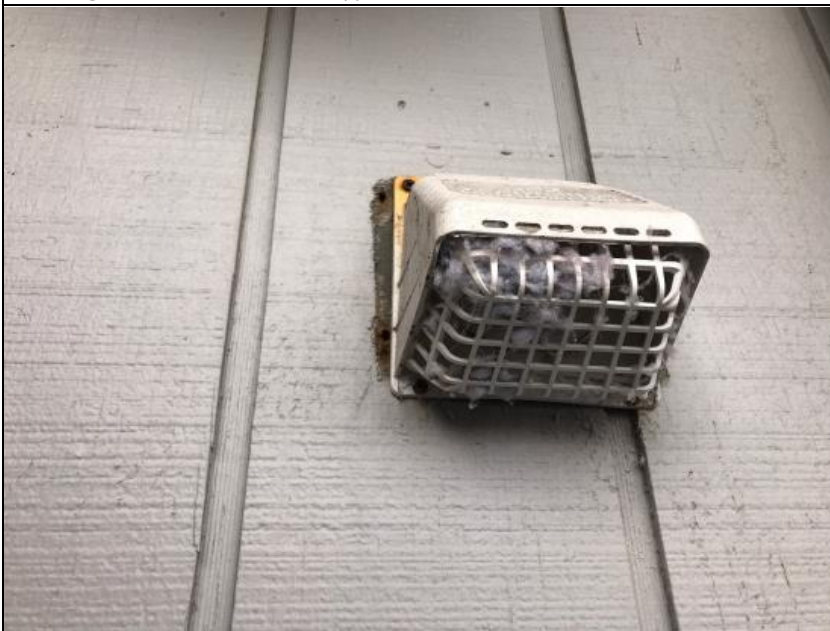
**Building #**1238, **Unit #**482

**Description:** Omitted flashings at wall penetrations. Dryer vents were also observed to not be tight lined and incorrectly have screens that trap lint.

**Photo Notes:** Code prohibits screens on dryer ducts. Blocked lint can be a fire hazard.

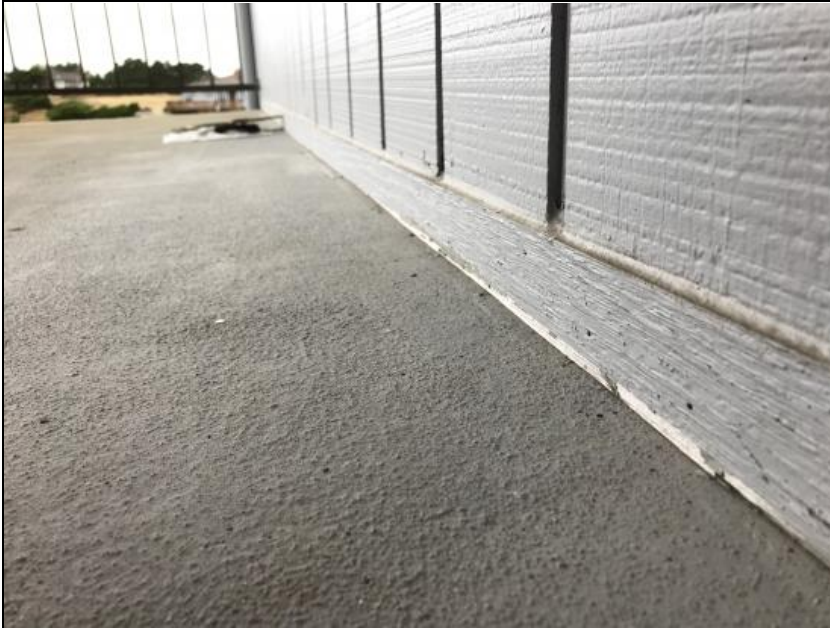
**Building #1238, Unit #484**

**Photo Notes:** Cladding tight to walking surface; unknown deck-to-wall transition

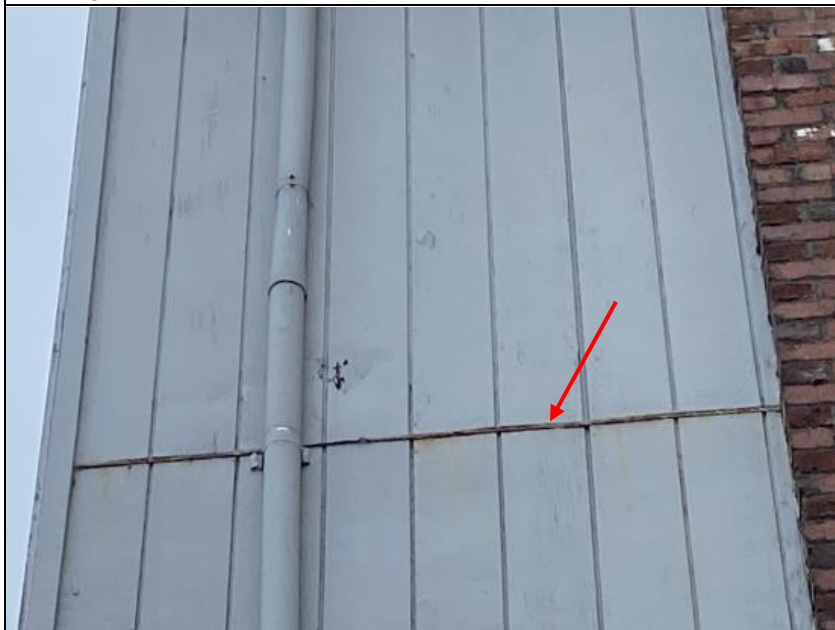
**Building #1238, Unit #N/A**

**Description:** Corrosion at sheet metal flashing located at siding panel breaks.

**Photo Notes:** Corroded metal flashing

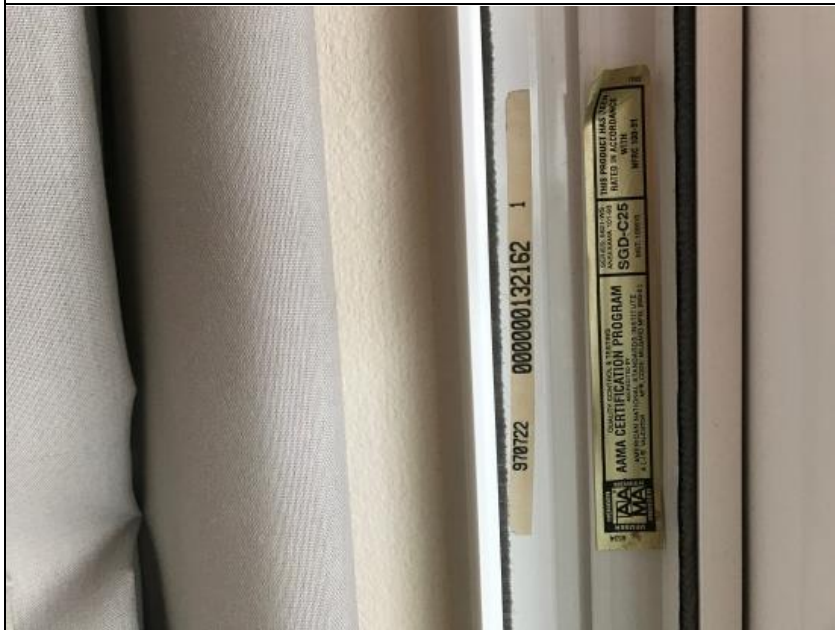
**Building #1238, Unit #482**

**Description:** J2 observed several window AAMA Gold Labels in sliding glass door and window units. While there are many varying performance grades noted, in all cases the performance ratings appear to be significantly less than what is required to resist code required loading.

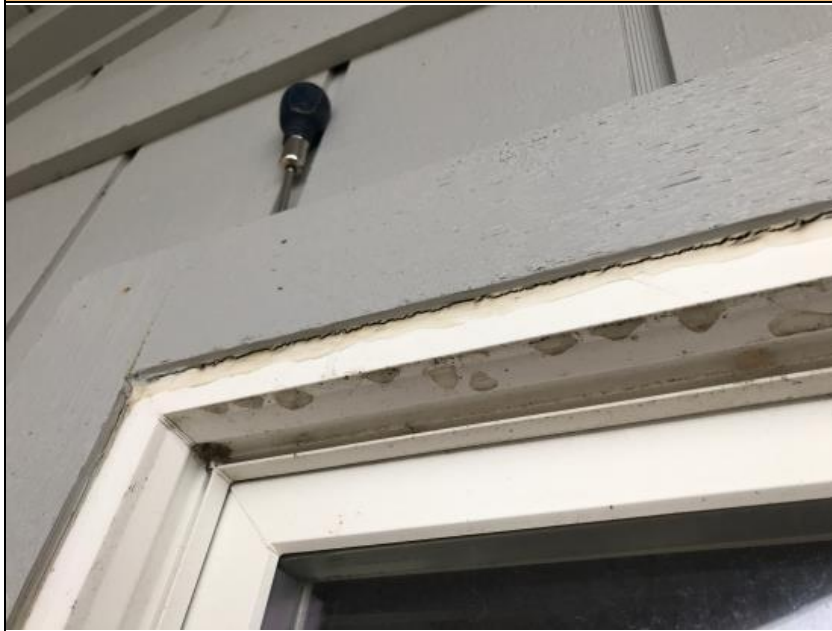
**Building #1238, Unit #485**

**Photo Notes:** Omitted head flashing and frame is sealed to trim and blocks water egress.

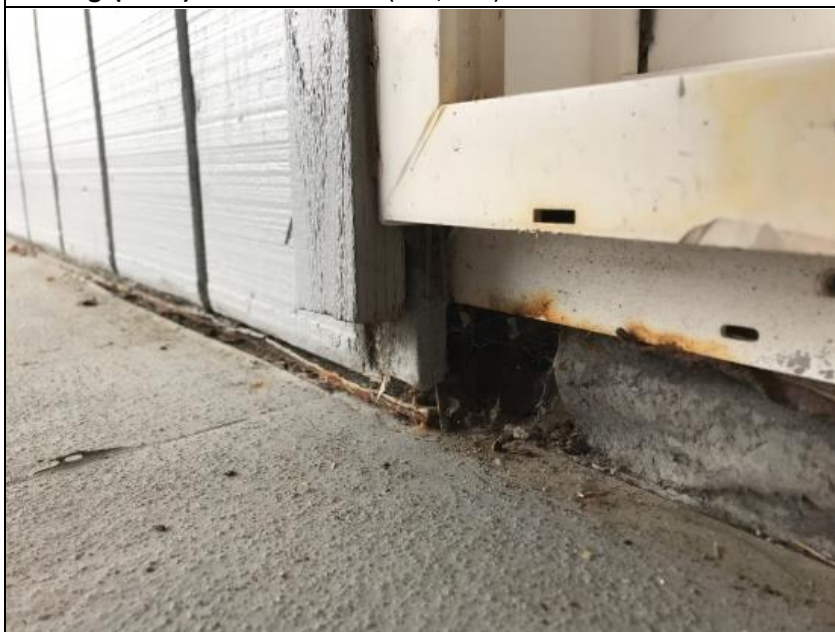
**Building #1238, Unit #479**

**Description:** Corroded sill pans at sliding glass doors on the buildings West face.

**Photo Notes:** Sill pan has completely corroded away.

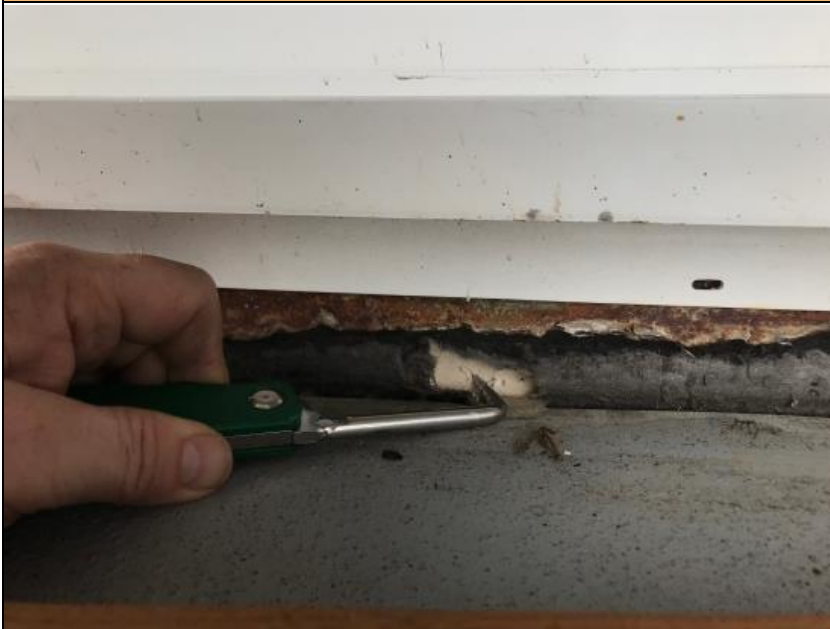
**Building #1238, Unit #479**

**Photo Notes:** Sill pan has completely corroded away.

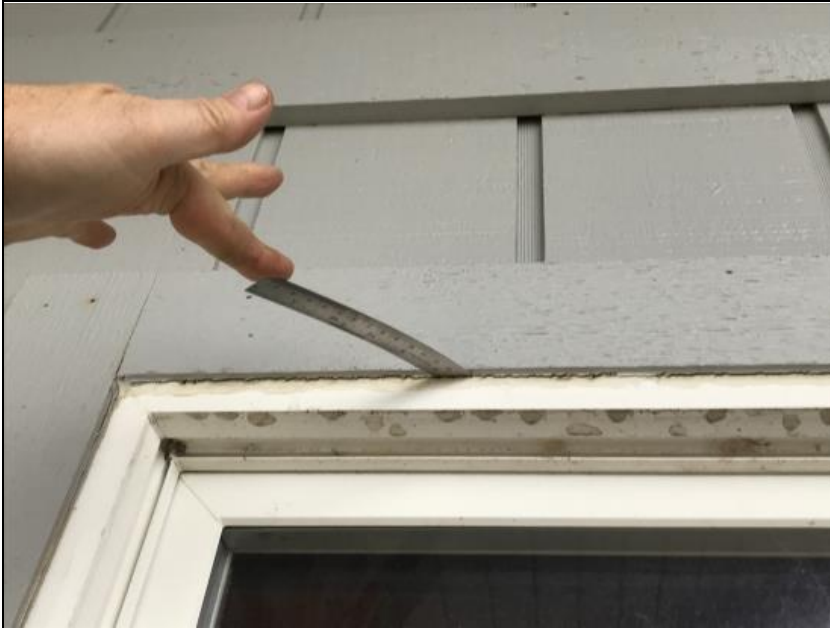
**Building #1238, Unit #485**

**Description:** Omitted dynamic sealant joints. Window frames are installed tight to wood trim which does not allow proper expansion/contraction. Sealant is failing.

**Severity Rating:** 2/3

**Photo Notes:** Failed sealant (however, as noted in item above, this gap should be open and should have head flashing directing water out)

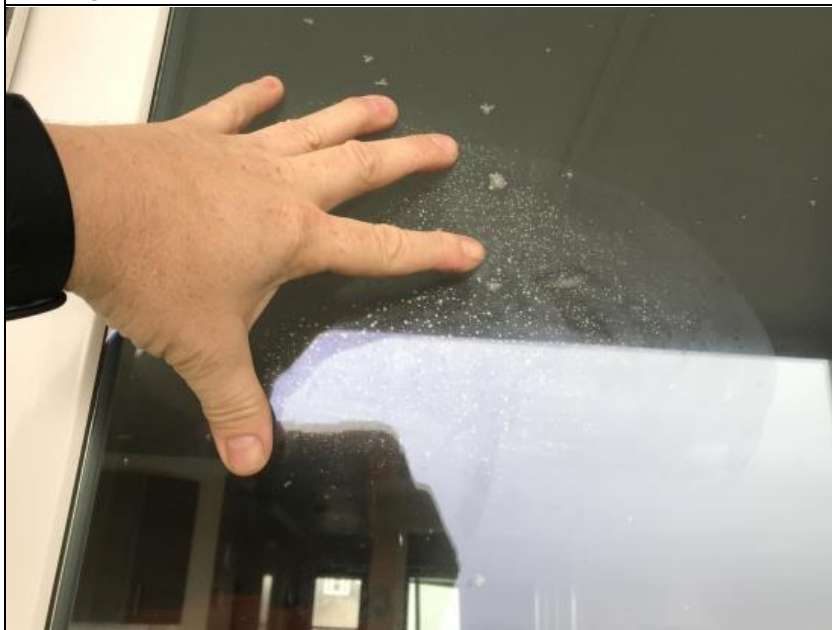
**Building #1238, Unit #482**

**Description:** Failed IGU (Insulated Glass Units); Moisture observed between window glazing panels.

**Severity Rating:** 3/6

**Photo Notes:** Fogged windows (failed IGU)

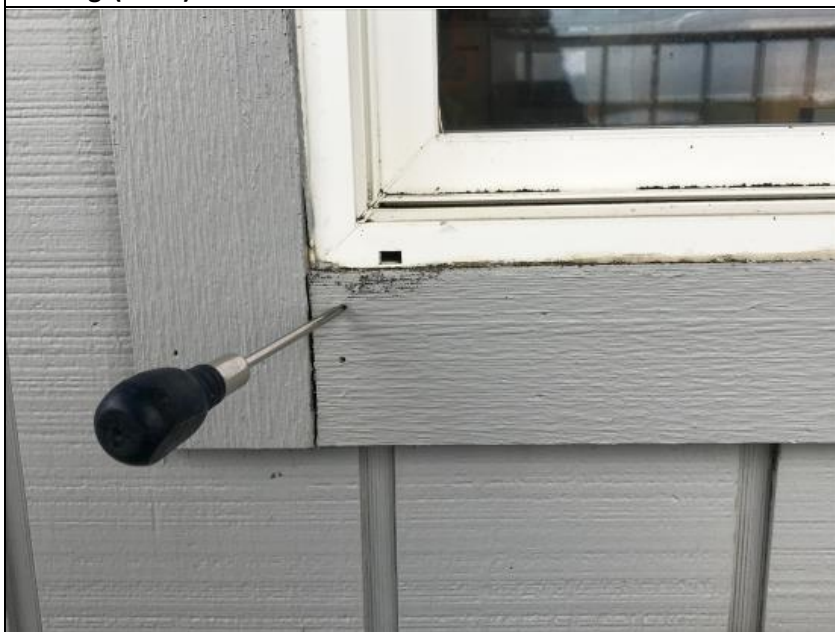
**Building #1238, Unit #485**

**Description:** Water damaged trim

**Photo Notes:** Water damaged trim below window

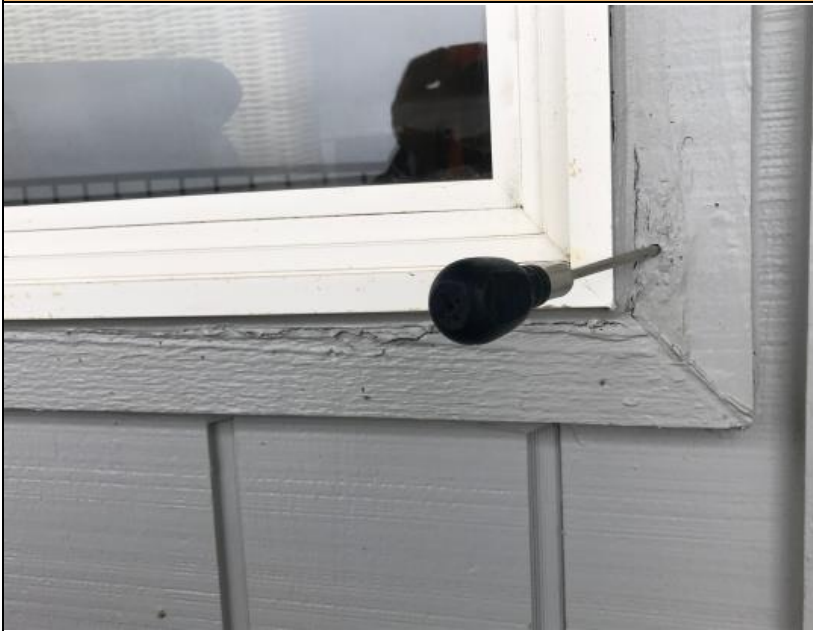
**Building #1238, Unit #482**

**Photo Notes: Water damaged window trim**

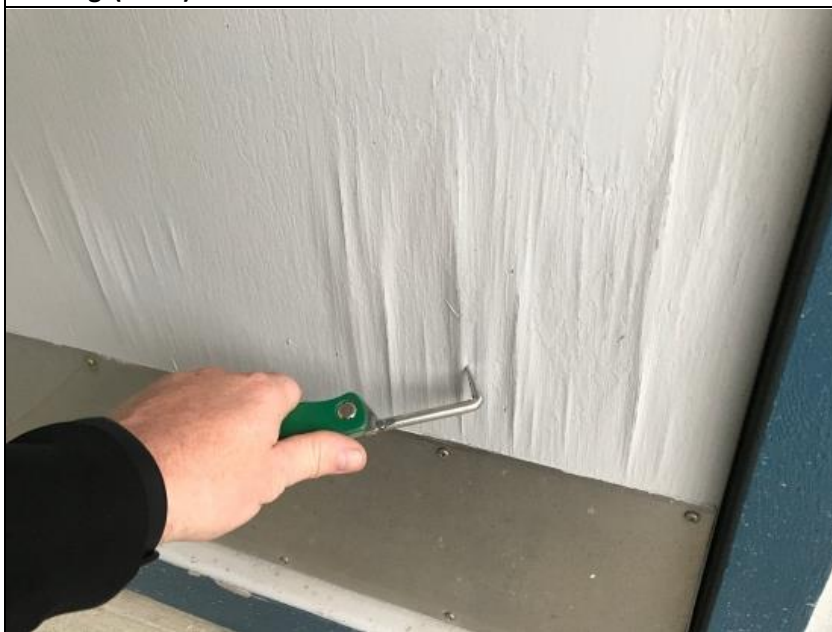
**Building #1238, Unit #468**

**Description:** Water damaged and delaminating swing doors at several locations on the East & West building face.

**Severity Rating:** 2

**Photo Notes:** Water damaged wood panel door

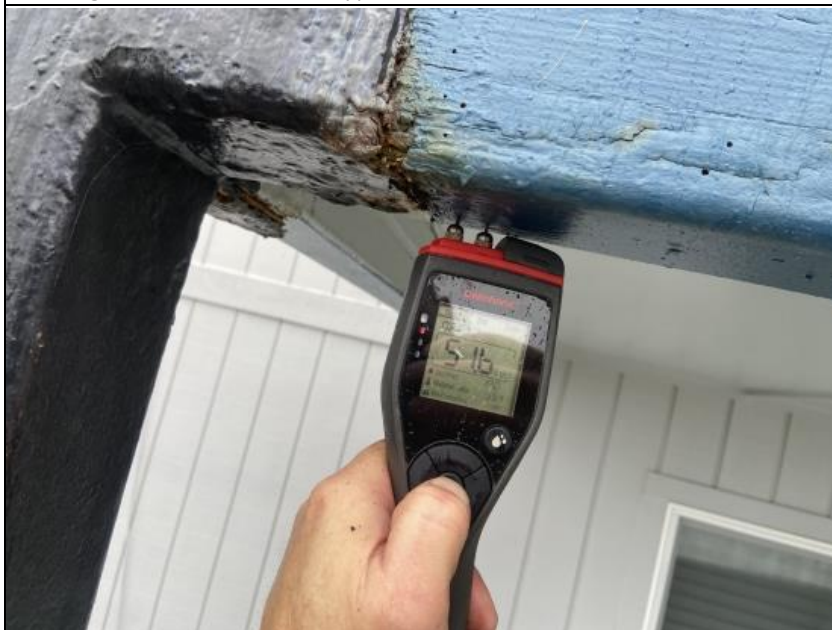
**Building #N/A, Unit #N/A**

**Description:** Water damage at deck and walkway beams.

**Severity Rating:** 1/2/6

**Photo Notes:** Water damaged wood beam

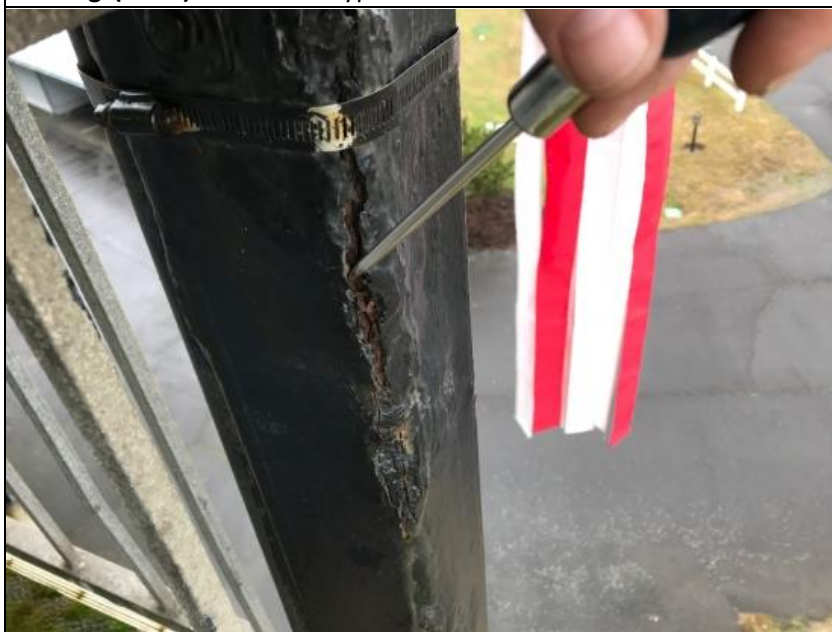
**Building #1238, Unit #485**

**Description:** Corrosion and damage in structural steel framing.

**Severity Rating:** 2

**Photo Notes:** Water damaged steel column

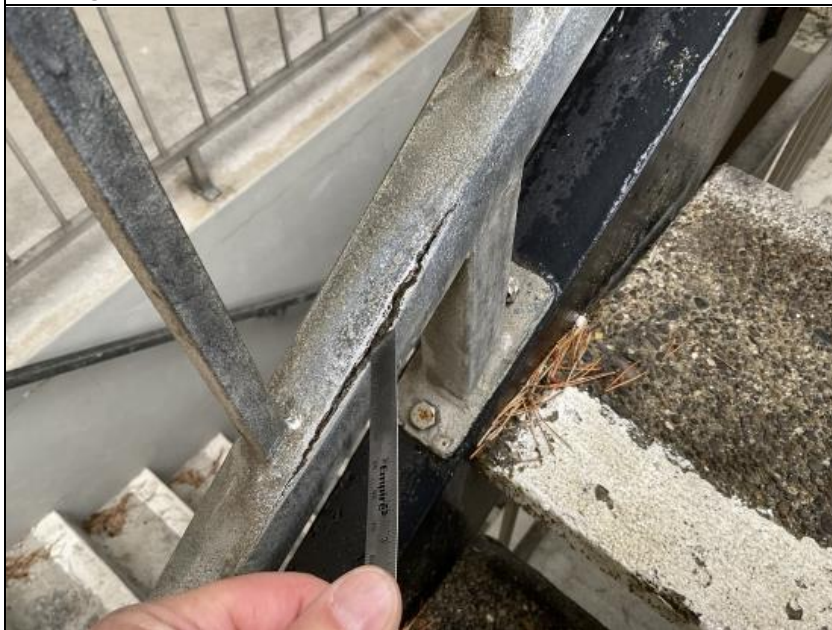
**Building #**N/A, **Unit #**N/A

**Description:** Corrosion at guardrail components.

**Severity Rating:** 2

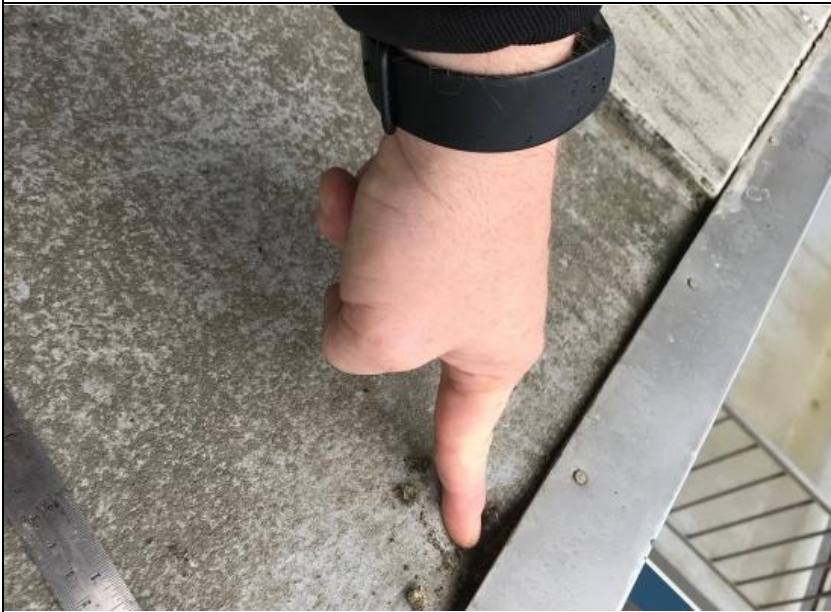
**Building #**1238, **Unit #**479

**Description:** Water damage to the wood structure was observed beneath the waterproofing at many deck and entryway locations.

**Severity Rating:** 2

**Photo Notes:** Water damaged deck sheathing

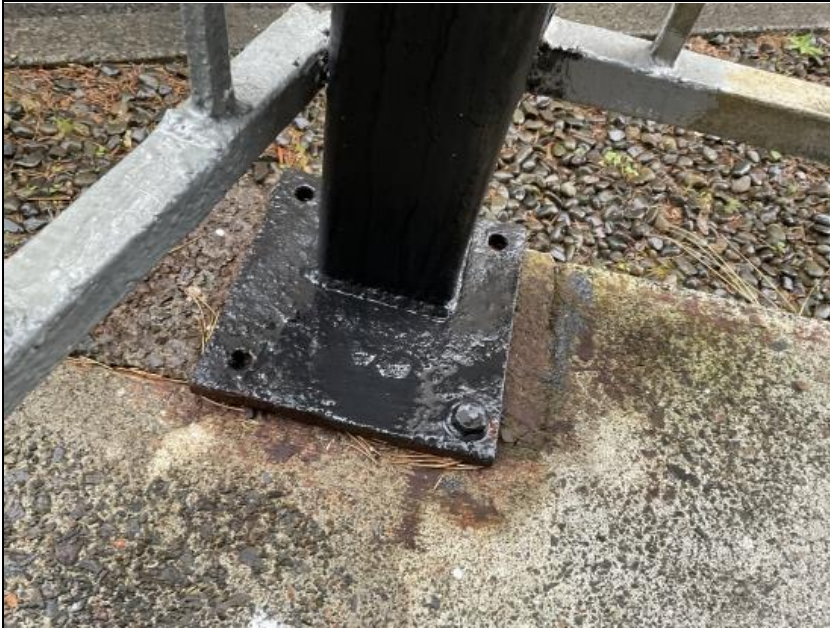
**Building** #N/A, **Unit** #N/A

**Photo Notes:** Omitted post base fasteners in steel column to footing

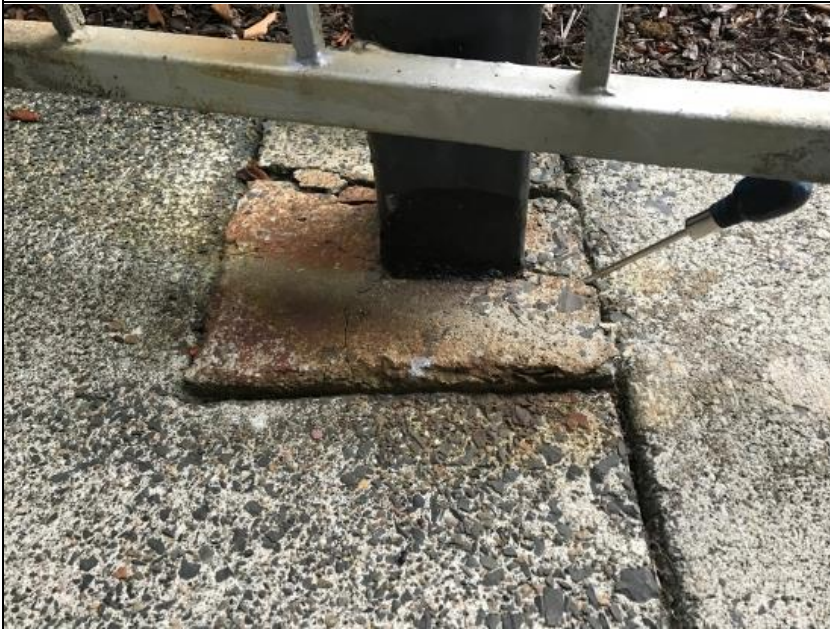
**Building** #1238, **Unit** #N/A

**Description:** Concrete damage was observed at footings supporting steel columns and at structural concrete columns.

**Photo Notes:** Cracked concrete at base of steel column; apparent incorrectly detailed closure pour

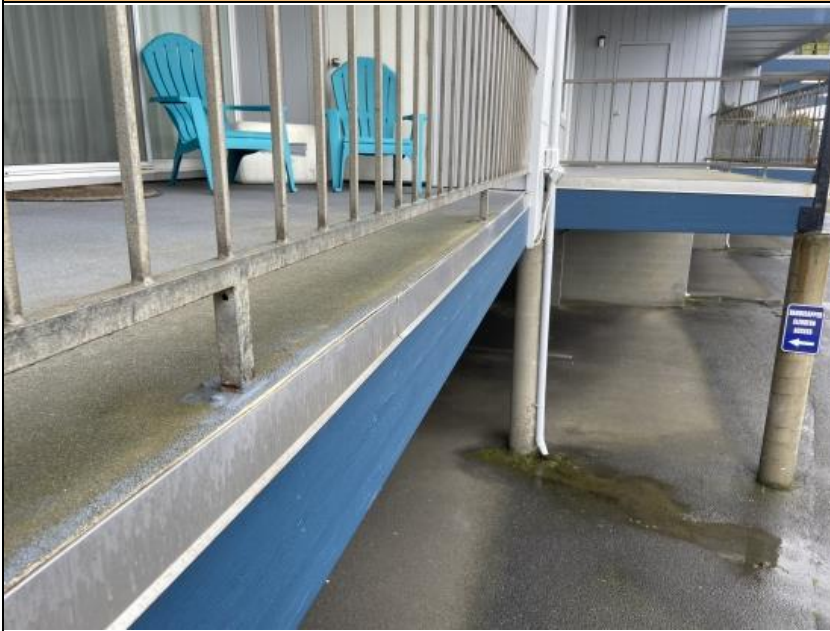
**Building #1238, Unit #N/A**

**Photo Notes:** Close up example of deck beam

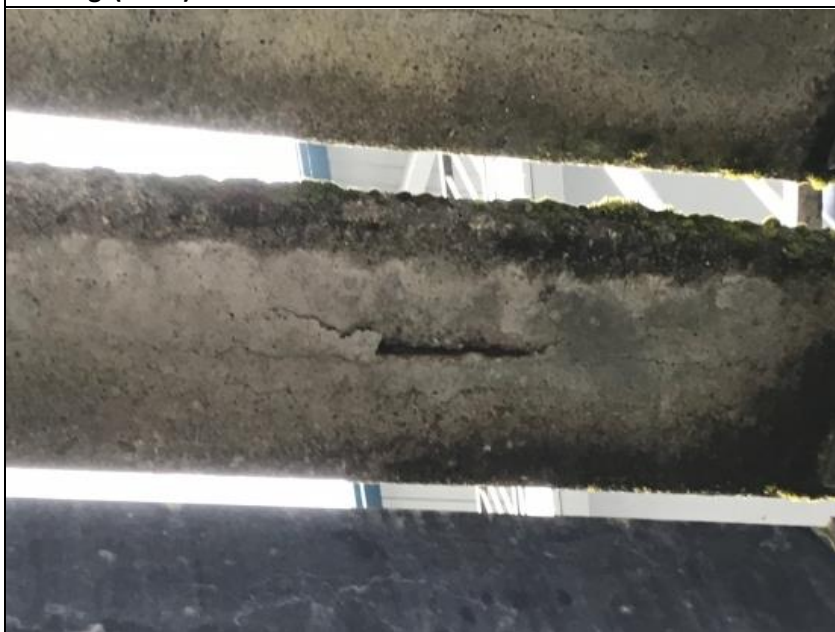
**Building #1238, Unit #N/A**

**Description:** Stair treads have cracking and/or exposed reinforcing steel.

**Photo Notes:** Cracking/spalling at concrete stair tread

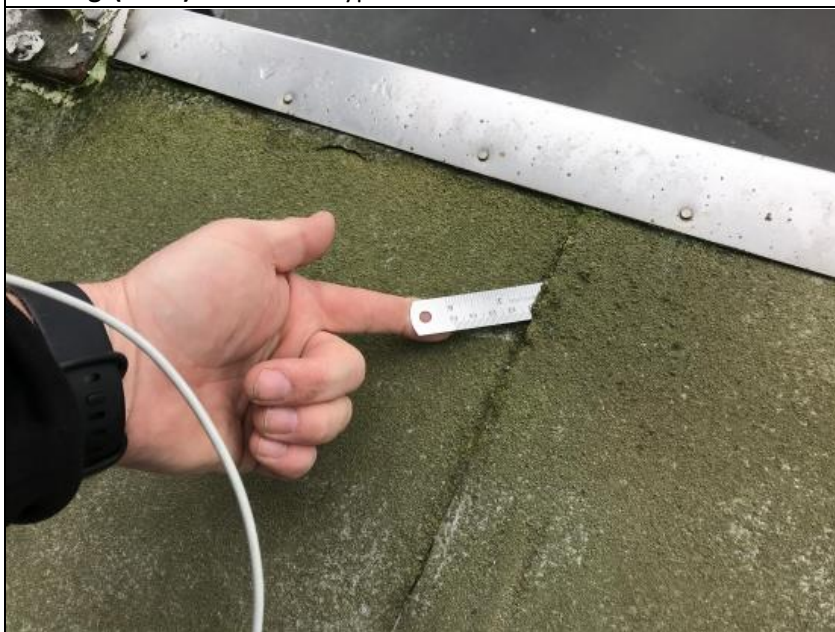
**Building #**1238, **Unit #**479

**Description:** Cracked, failing and adhesion failures on deck coatings.

**Photo Notes:** Failed coating at seam

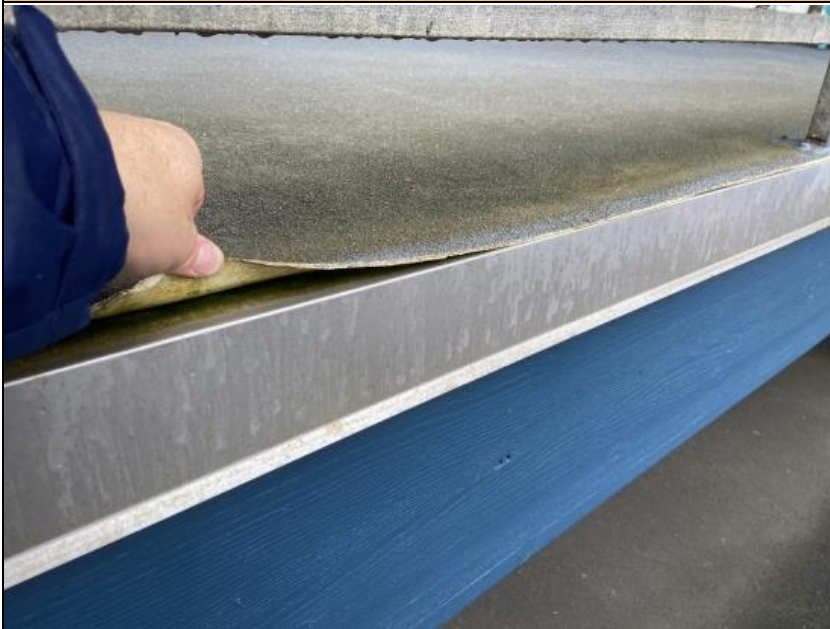
**Building #1238, Unit #N/A**

**Photo Notes:** Failed coating/no adhesion at deck edge

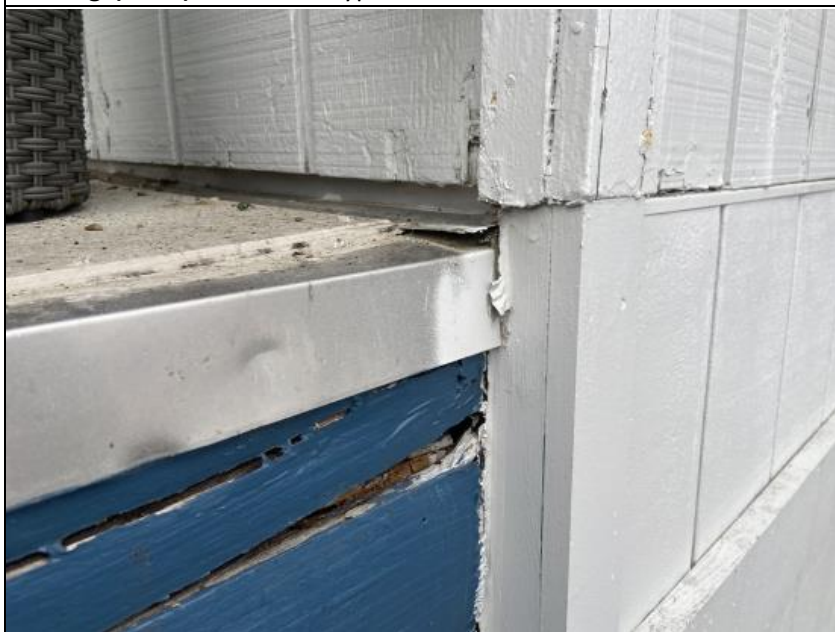
**Building #1238, Unit #479**

**Description:** Improperly lapped and unsealed drip edge flashing

**Photo Notes:** Omitted Diverters and no sealant at flashing lap; note water damaged deck beam.
