# PACIFIC VIEW CONDOMINIUMS

## Preliminary Building Envelope and Limited Structural Observations

**Address:** 128 N Marion Ave, Gearhart, OR 97138

**Date:** November 22, 2022

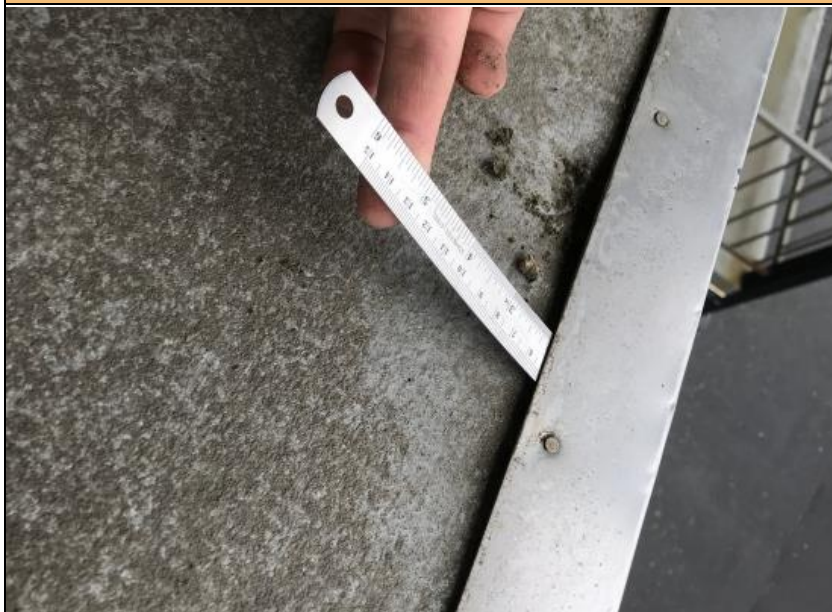
**Building #1238, Unit #479**

**Photo Notes:** Omitted coating and/or sealant at edge of deck and deck edge flashing. Top fasteners are also unsealed.

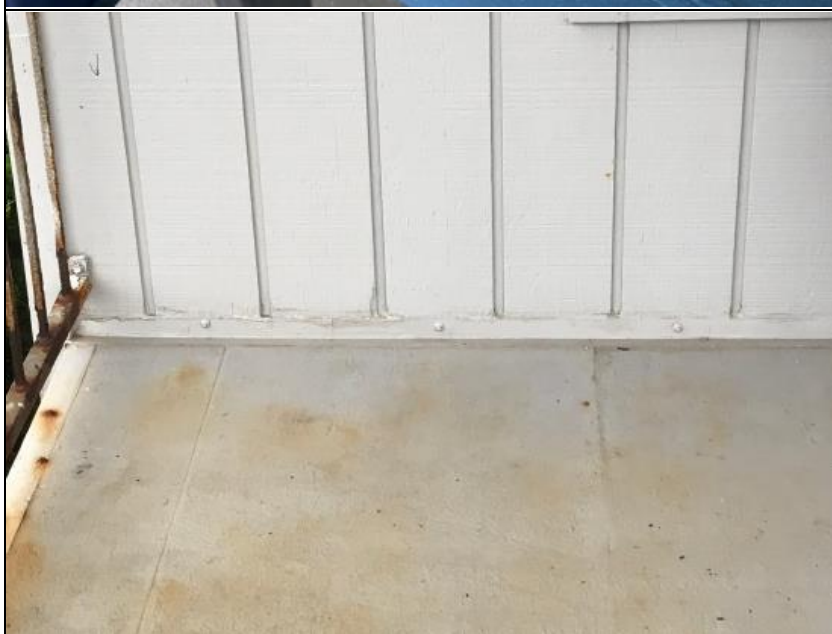
**Building #1238, Unit #N/A**

**Photo Notes:** Omitted coating/sealant at deck edge (left side of photo) and improper deck to wall flashing (center of photo)

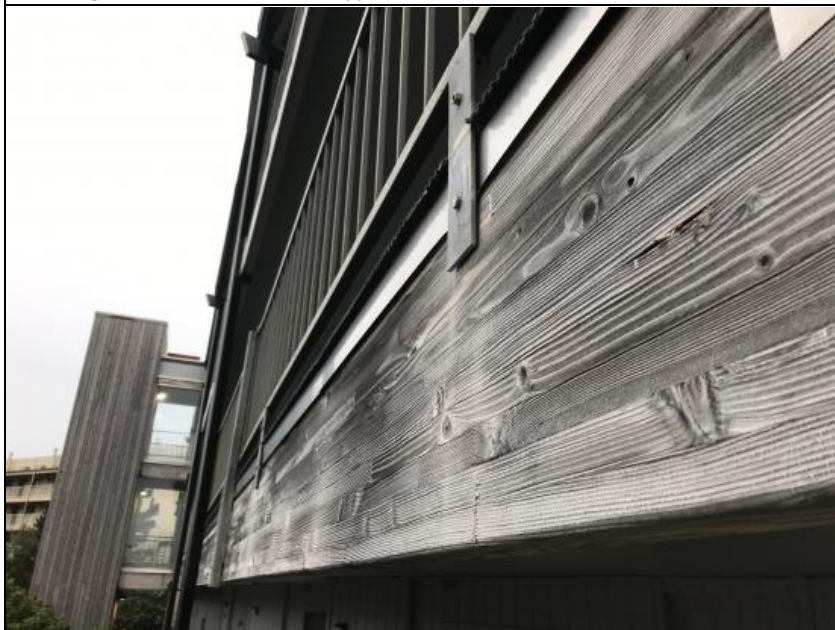
**Building #1238, Unit #N/A**

**Photo Notes:** Example of exposed GLB

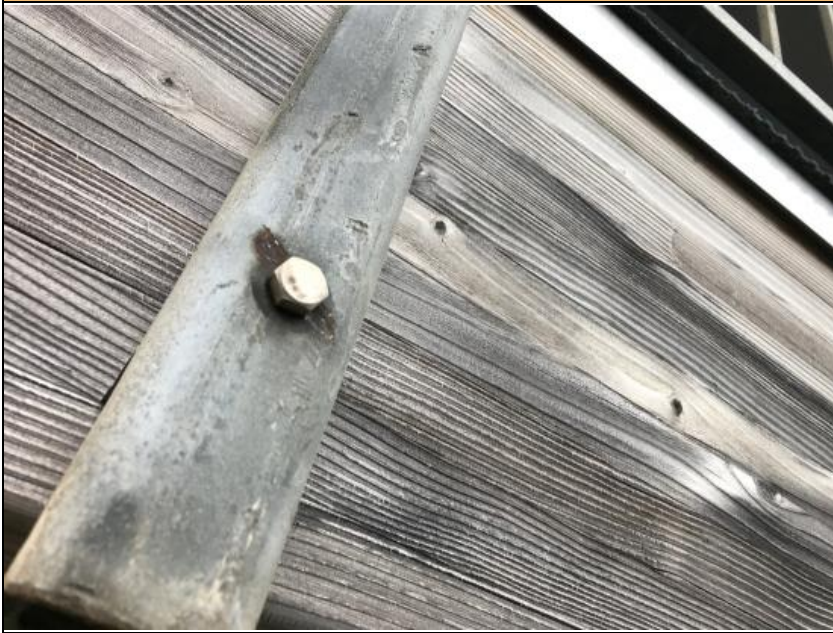
**Building #1238, Unit #N/A**

**Photo Notes:** Example of exposed GLB

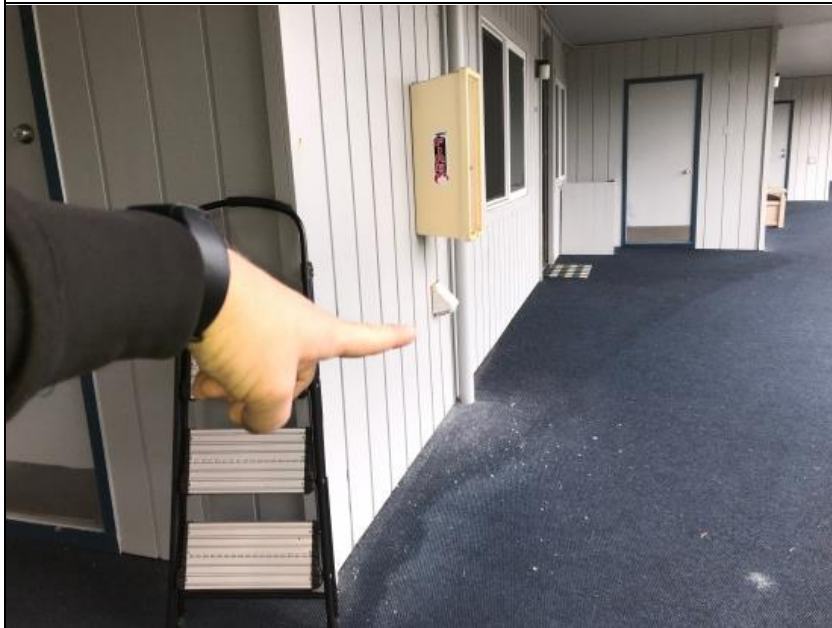
**Building #1238, Unit #482**

**Description:** Front entryways are covered with outdoor carpet. This material is not suitable for this condition. It is wet, prevents drying, and is making it impossible to observe the condition of the deck structure.

**Photo Notes:** Water stains at carpet

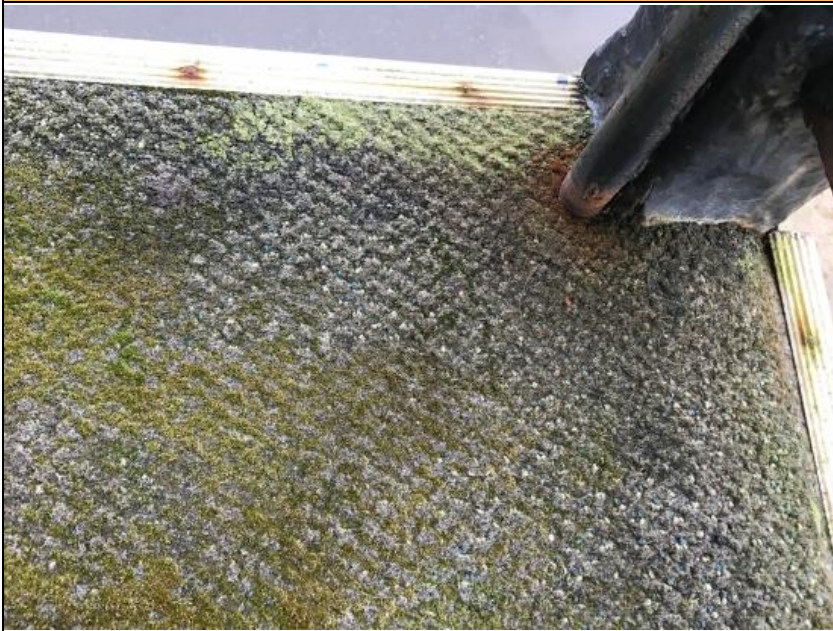
**Building #1238, Unit #485**

**Photo Notes: Water damaged carpet**

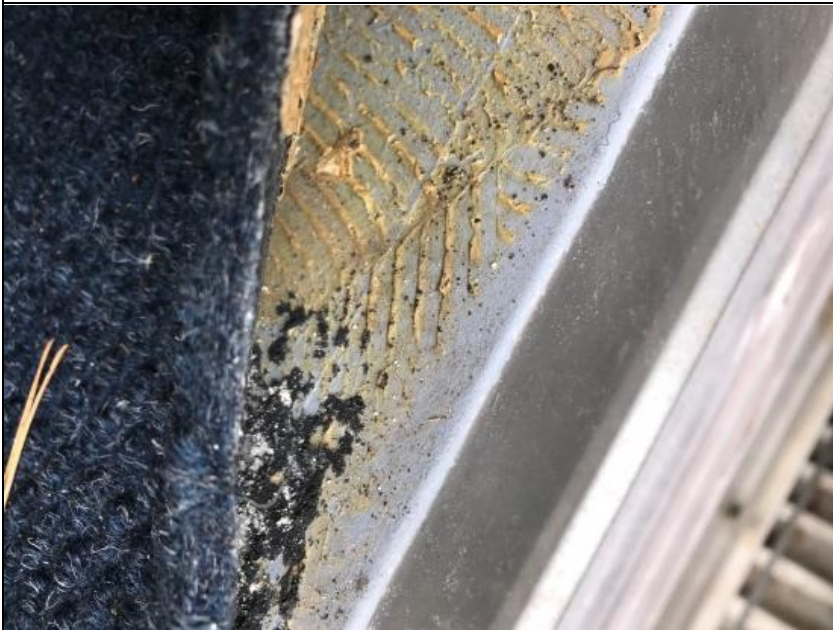
**Building #1238, Unit #N/A**

**Photo Notes: Water damaged carpet**

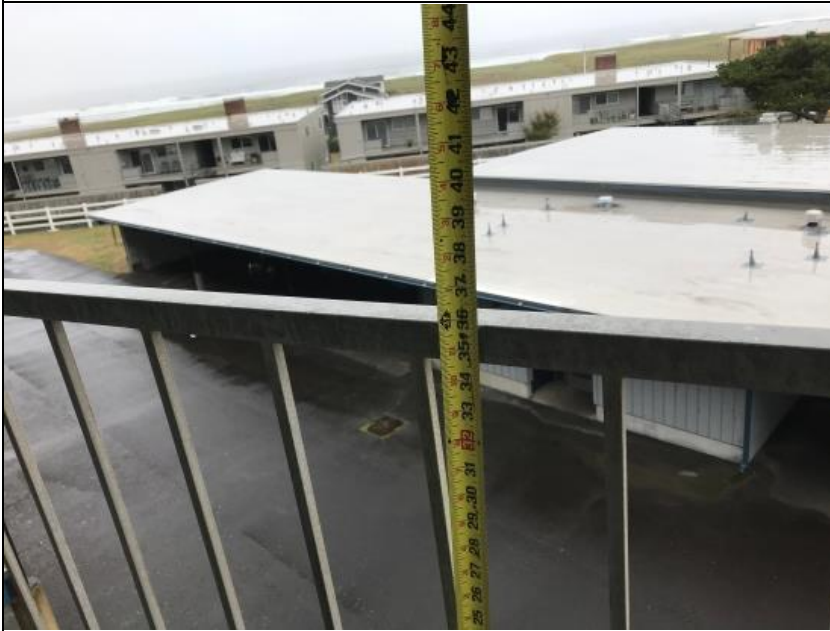
**Building #1238, Unit #479**

**Photo Notes:** Existing guardrail height is 36".

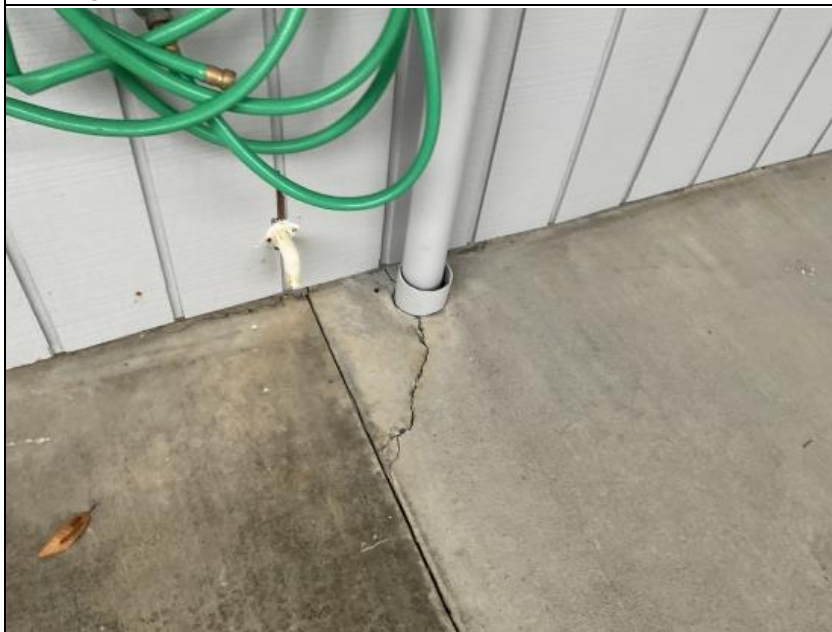
**Building #N/A, Unit #N/A**

**Description:** Cracks in concrete slab on grade were observed at several locations.

**Photo Notes:** Concrete cracking starting at rain drain penetration

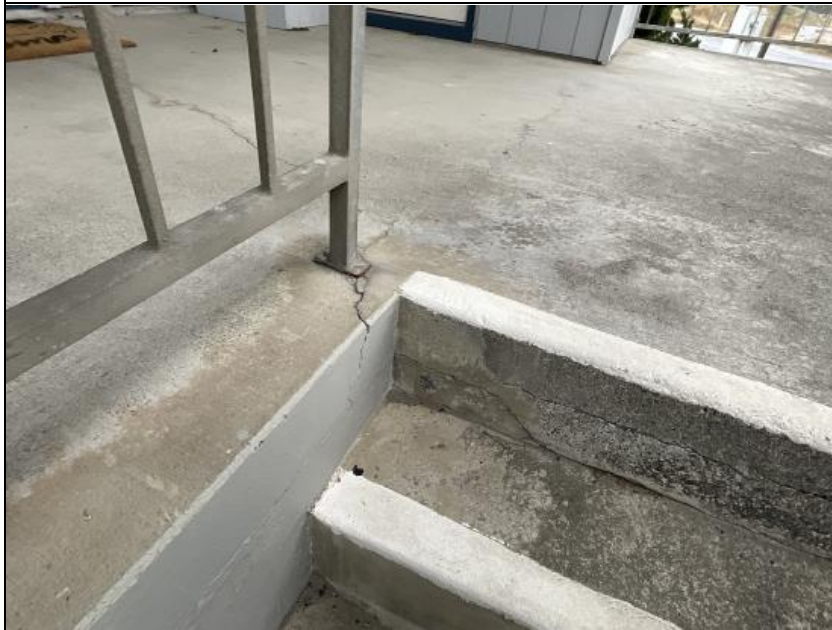
**Building #**N/A, **Unit #**N/A

**Photo Notes:** Concrete cracking

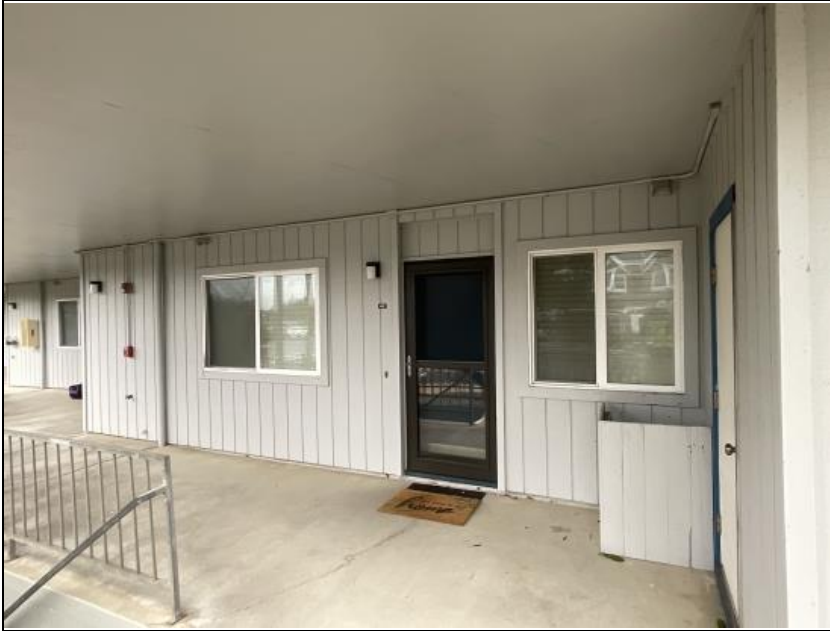
**Building #N/A, Unit #N/A**

**Photo Notes:** Concrete cracking at entryway slab
